Appendix B. Physical Environment Audit

This Appendix includes three sections from [KMA](#), the project team's physical environment experts:

TOWN HALL

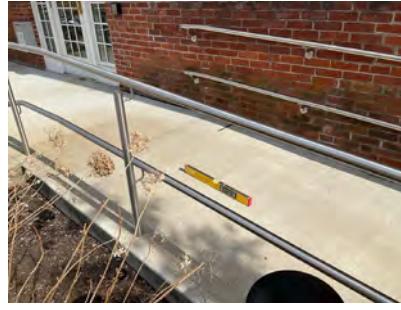
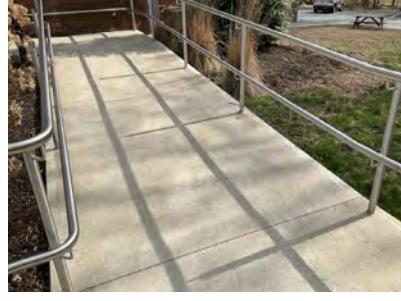
Provide the required clear floor space adjacent to the EV charging station. Unit Cost: \$1,000 ea. Quantity: 1	\$1,000
2.	Ramp to Accessible Entrance The running slope of the ramp is >8.3%, @ up to 9.2%. The edge protection curb or barrier does not prevent the passage of a 4" min. sphere, @ 8".	2010 ADAS 405.2 2010 ADAS 405.9.2

Repair non-compliant sections of the ramp. Unit Cost: \$25/SF Est. Quantity: 1250 SF Provide compliant edge protection at the ramp. Unit Cost: \$50/LF Est. Quantity: 65 LF	\$6,375

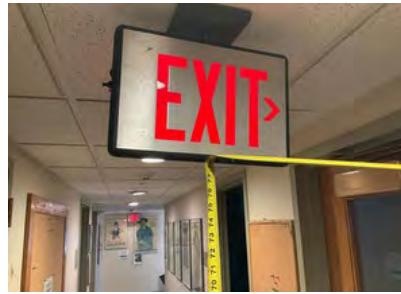
4.	Exit Signs (Basement) The headroom under the illuminated exit signs is <80 " of vertical clearance, @ 77".	2010 ADAS 307.4

Relocate the illuminated exit sign to provide the required headroom. Unit Cost: \$150 ea. Quantity: 4	\$600

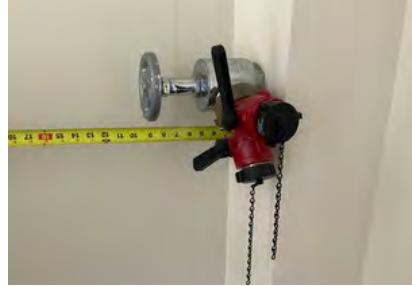
6.	Interior Stairwells (Typical) The element protrudes >4" into the circulation space, @ up to 9".	2010 ADAS 307.2

Install a cane detectable object below the element. Unit Cost: \$250 ea. Quantity: 6	\$1,500

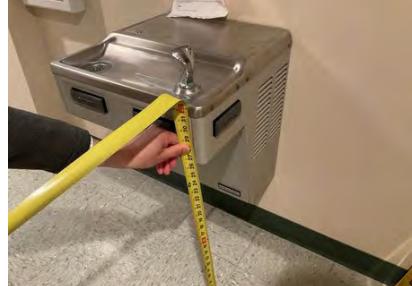
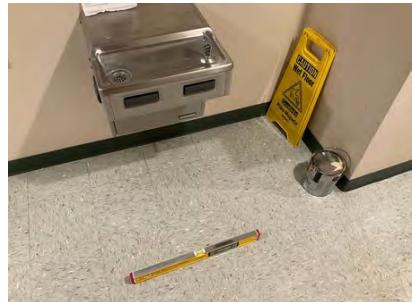
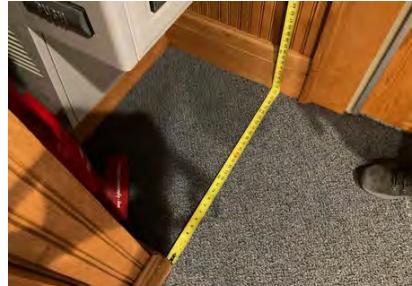
7.	Drinking Fountains A drinking fountain for seated persons is not provided. <i>Observed on the basement and second floor.</i> The drinking fountain lacks the required knee/toe clearance, @26", and the required clear floor space adjacent to it, due to the excessively steep floor. <i>Observed in the basement.</i> The clear floor space of the drinking fountain is not centered for a forward approach. <i>Observed on the second floor.</i>	2010 ADAS 211.2 2010 ADAS 602.2

Add a drinking fountain for seating persons. Unit Cost: \$1,500 ea. Quantity: 2 Regrade the area adjacent to the drinking fountain. Unit Cost: \$1,000 ea. Quantity: 1 Raise the drinking fountain in the basement. Unit Cost: \$750 ea. Quantity: 1 Relocate the drinking fountain on the second floor to a location where provides the required centered clear floor space. Unit Cost: \$1,500 ea. Quantity: 1	\$6,250

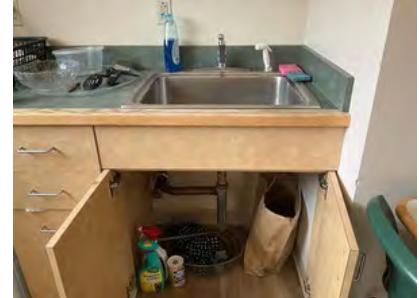
<p>Install tactile/Braille signage on the latch side of the door. Coordinate with location and height requirements.</p> <p>Unit Cost: \$100 ea.</p> <p>Quantity: 20</p>	\$2,000
9.	<p>Second Floor Staff Room</p> <p>The sink and counters are >34" AFF, @ 36".</p>	2010 ADAS 804.3.2

<p>Lower the sink and counters to 34" AFF max.</p> <p>Unit Cost: \$3,000 ea.</p> <p>Quantity: 1</p>	\$3,000

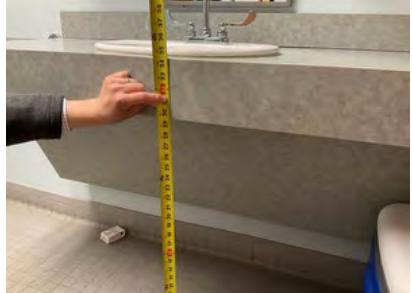
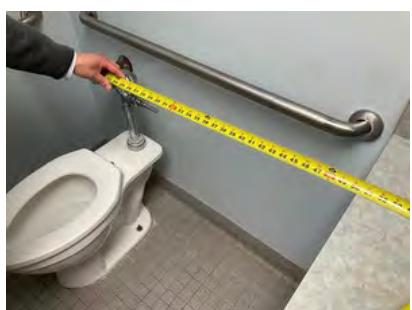
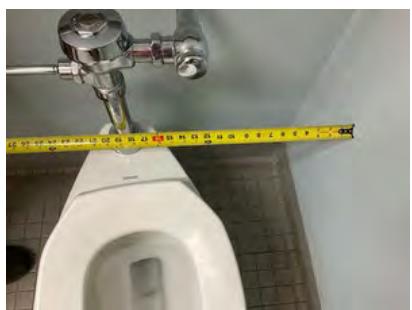
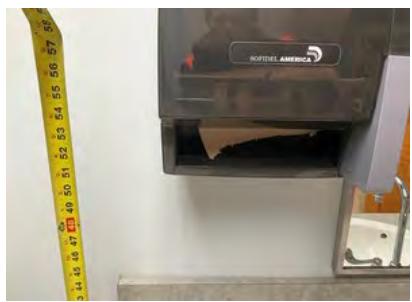
10.	<p>Men's & Women's Single-user Toilet Room (Basement)</p> <p>The lavatory is mounted >34" AFF, @ 35".</p> <p>The pipes underneath the lavatory/sink are not insulated.</p> <p><i>Observed in the Men's only.</i></p> <p>The toilet lacks the required clearance around it, @ 50 ½", due to the lavatory.</p> <p>The toilet centerline is not 16"-18" from the nearest adjacent side wall, 18 ¾".</p> <p>The toilet paper dispenser is not located 7"-9" from the front of the toilet, @ 11".</p> <p><i>Observed in the Men's only.</i></p> <p>The dispenser is located <12" above the grab bar, @ 9".</p> <p>The paper towel dispensers is mounted >48" AFF, @ 51".</p>	<p>2010 ADAS 606.3 2010 ADAS 606.5 2010 ADAS 604.3 2010 ADAS 604.2 2010 ADAS 604.7 2010 ADAS 609.3 2010 ADAS 308.3.1</p>

<p>Lower the lavatory. Unit Cost: \$750 ea. Quantity: 2</p> <p>Install insulation around the lavatory pipes. Unit Cost: \$100 ea. Quantity: 1</p> <p>Modify the lavatory. Unit Cost: \$750 ea. Quantity: 2</p> <p>Reposition the toilet. Unit Cost: \$500 ea. Quantity: 1</p> <p>Relocate the toilet paper dispenser. Unit Cost: \$50 ea. Quantity: 1</p> <p>Remove the toilet paper dispenser above the grab bar. Unit Cost: \$50 ea. Quantity: 2</p> <p>Relocate the paper towel dispenser. Unit Cost: \$50 ea. Quantity: 2</p>	\$2,350

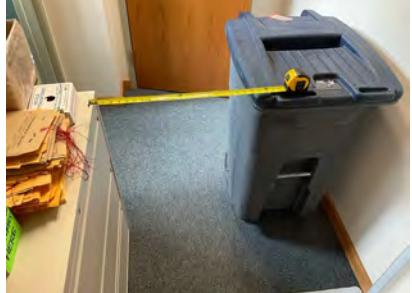
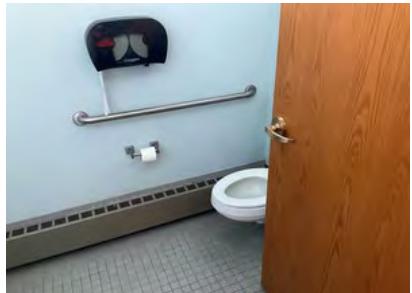
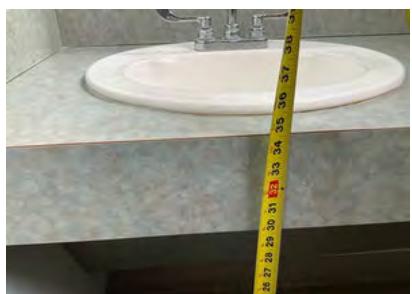
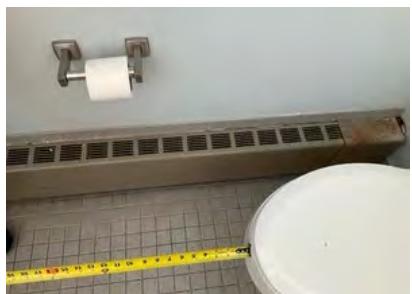
11.	<p>Men's and Women's Single-user Toilet Rooms (First Floor)</p> <p>The walkway is <36" wide in the ante room leading to one of the toilet rooms.</p> <p>The bathroom lacks the required 30"x48" clear floor space beyond the swing of the door.</p> <p>The lavatory is mounted >34" AFF, @ 35 1/4".</p> <p>The bottom of the reflective surface of the mirror is >40" AFF, @ 43".</p> <p><i>Observed in Men's only.</i></p> <p>The toilet paper dispenser is not located 7"-9" from the front of the toilet, @ 11".</p> <p>The dispenser is located <12" above the grab bar, @ 9".</p> <p>The dryers and dispensers are mounted >48" AFF, @ 50 1/2".</p> <p>The coat hook is >48" AFF, @ 62".</p> <p><i>Observed in Men's only.</i></p>	<p>2010 ADAS 403.5.1 2010 ADAS 603.2.3 2010 ADAS 606.3 2010 ADAS 603.3 2010 ADAS 604.7 2010 ADAS 609.3 2010 ADAS 308.3.1 2010 ADAS 604.8.3</p>

<p>Relocate the recycling bin and furniture. Unit Cost: \$50 ea. Quantity: 2</p> <p>Reverse the swing of the door. Unit Cost: \$100 ea. Quantity: 2</p> <p>Lower the lavatory. Unit Cost: \$750 ea. Quantity: 2</p> <p>Lower the mirror. Unit Cost: \$50 ea. Quantity: 1</p> <p>Relocate the toilet paper dispenser. Unit Cost: \$50 ea. Quantity: 2</p> <p>Remove the toilet paper dispenser above the grab bar. Unit Cost: \$50 ea. Quantity: 2</p> <p>Relocate the soap and paper towel dispensers. Unit Cost: \$50 ea. Quantity: 4</p> <p>Provide a coat hook mounted no higher than 48" AFF. Unit Cost: \$50 ea. Quantity: 1</p>	\$2,300

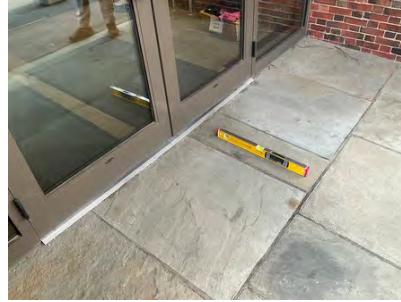
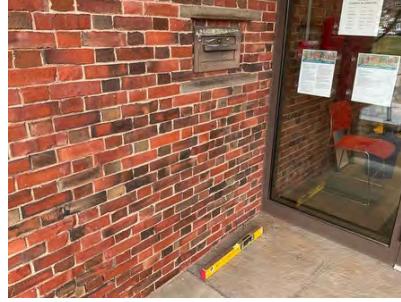
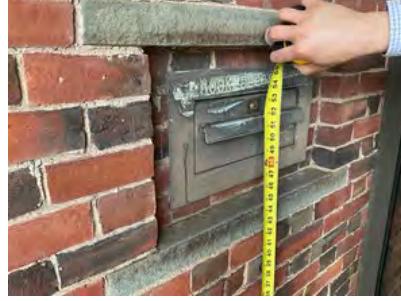
3.	<p>Main Entrance (First Floor)</p> <p>The door lacks a level landing.</p> <p>The book return slot lacks the required 30"x48" minimum clear floor space adjacent to it.</p> <p>The operable parts of the element are not 15"-48" AFF, @ 50 1/2".</p>	<p>2010 ADAS 404.2.4.4</p> <p>2010 ADAS 305.3</p> <p>2010 ADAS 308.2.1</p>

<p>Regrade the door landing. Unit Cost: \$1,000 ea. Quantity: 1</p> <p>Further study required for the book return slot. Consider installing an alternative, accessible book drop near the entrance. Unit Cost: \$0</p>	\$1,000
----	--	--	--	--	---------

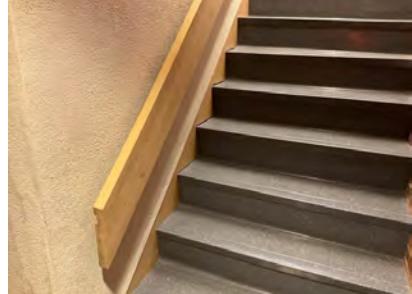
4.	Interior Stairs (Ground Floor – First Floor) <p>The handrail perimeter is not 4"-6 1/4" for a non-circular cross-section, @ 18".</p> <p><i>Observed in rear stairway to employee shop.</i></p>	2010 ADAS 505.7.2

<p>Install compliant handrails on both sides of the stair.</p> <p>Unit Cost: \$50/LF</p> <p>Quantity: 17 LF</p>	\$850

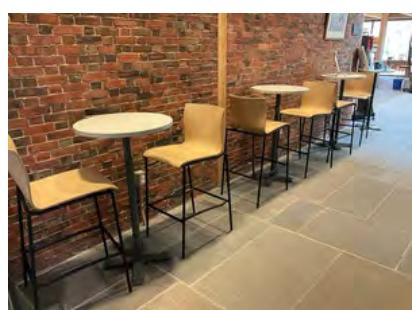
6.	Tables at Lobby (First Floor) <p>The dining/work surface lacks the required knee/toe clearances.</p> <p>The dining/work surface is not 28"-34" AFF, @ 42".</p>	2010 ADAS 902.2 2010 ADAS 902.3

<p>Provide at least one dining/ work surface, and no less than 5% of the total number of dining/ work surface, that provides compliant knee and toe clearance.</p> <p>Unit Cost: \$250 ea.</p> <p>Quantity: 1</p>	\$250

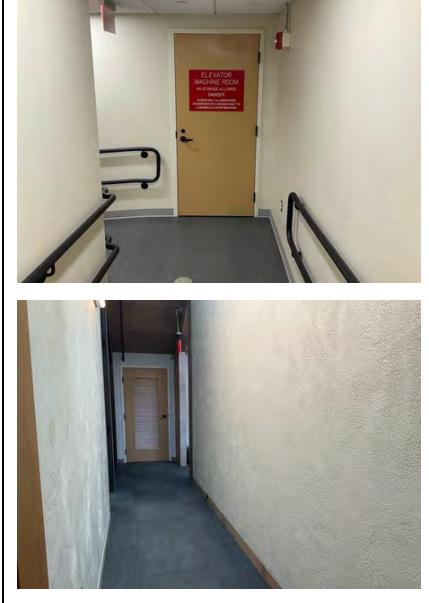
7.	<p>Signage (Typical)</p> <p>There is no tactile/Braille signage mounted on the latch side of the door.</p> <p><i>Observed in the basement/ground floor, first floor to basement staff work area, and second floor closet door.</i></p> <p><i>NOTE: During our audit, KMA noticed that the braille dots of certain braille signs were missing and/or falling off upon contact. It was not clear whether this condition was isolated or a malfunction of all signs throughout the building.</i></p>	2010 ADAS 703.4.2

<p>Install tactile/Braille signage on the latch side of the door. Coordinate with location and height requirements.</p> <p>Unit Cost: \$100 ea.</p> <p>Quantity: 5</p>	\$500

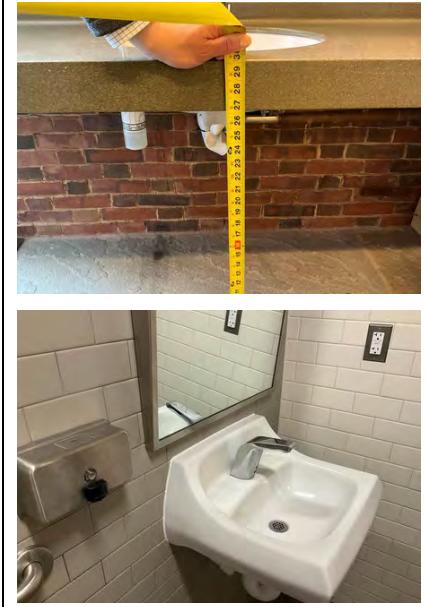
8.	<p>Single-User Toilet Rooms (First Floor)</p> <p>The lavatory lacks the required 27" high min. knee clearance, @ 26 $\frac{3}{4}$".</p> <p><i>Observed in toilet room #2 only.</i></p> <p>The bottom of the reflective surface of the mirror is >40" AFF, @ 40 $\frac{1}{2}$".</p>	2010 ADAS 606.2 2010 ADAS 603.3

<p>Modify the lavatory.</p> <p>Unit Cost: \$750 ea.</p> <p>Quantity: 1</p> <p>Lower the mirror.</p> <p>Unit Cost: \$50 ea.</p> <p>Quantity: 2</p>	\$850

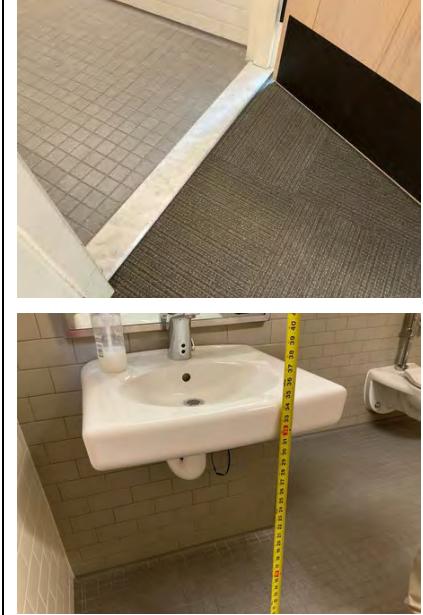
<p>Raise the baby changing station. Unit Cost: \$50 ea. Quantity: 1</p>	\$50
10.	<p>Single-User Toilet Room (Second Floor)</p> <p>The threshold is $>\frac{1}{4}$" high and $<\frac{1}{2}$" and not beveled at 1:2, or the material transition is $>\frac{1}{4}$" high.</p> <p>The lavatory is mounted >34" AFF, @ 34 $\frac{1}{4}$".</p>	2010 ADAS 404.2.5 2010 ADAS 606.3

<p>Replace the threshold or material transition. Unit Cost: \$250 ea. Quantity: 1</p> <p>Modify the lavatory. Unit Cost: \$750 ea. Quantity: 1</p>	\$1,000

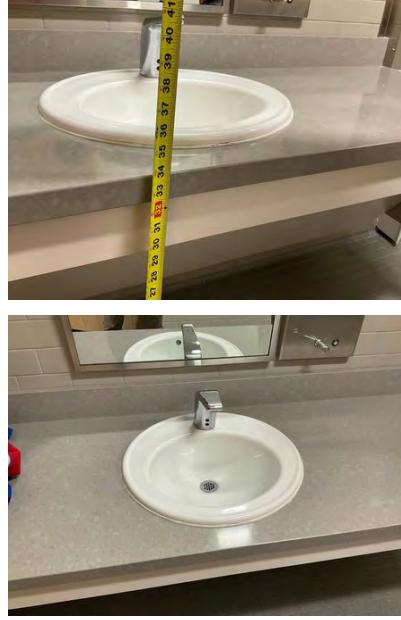
11.	<p>Men's & Women's Multi-user Toilet Rooms (Ground Floor)</p> <p>The lavatory is mounted >34" AFF, 34 ½".</p> <p>The bottom of the reflective surface of the mirror is >40" AFF, @ 41".</p> <p>Pull device are not provided on both sides of the stall door.</p> <p><i>Observed in Men's only.</i></p>	<p>2010 ADAS 606.3 2010 ADAS 603.3 2010 ADAS 604.8.1.2</p>

<p>Lower the lavatory. Unit Cost: \$750 ea. Quantity: 2</p> <p>Lower the mirror. Unit Cost: \$50 ea. Quantity: 2</p> <p>Install pull devices on both sides of the door, near the latch. Unit Cost: \$250 ea. Quantity: 1</p>	1,850
TOTAL FOR LIBRARY:					\$14,850

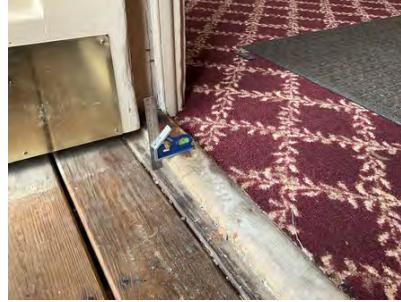
3.	Entrance The threshold is $>1/2"$, @ 1".	2010 ADAS 404.2.5

Replace the threshold. Unit Cost: \$250 ea. Quantity: 1	\$250
4.	Stairway The handrails are not 34"-38" AFF, @ 32". The handrail perimeter is not 4"-6 1/4" for a non-circular cross-section, @ 11". The clear space between the handrail and the adjacent surface is $<11/2"$, @ 0", at a section of the handrail. The stair lacks the required handrail extensions at the bottom of the stair flight. The headroom under the element is $<80"$ of vertical clearance, @ 72".	2010 ADAS 505.4 2010 ADAS 505.7.2 2010 ADAS 505.5 2010 ADAS 505.10.3 2010 ADAS 307.4

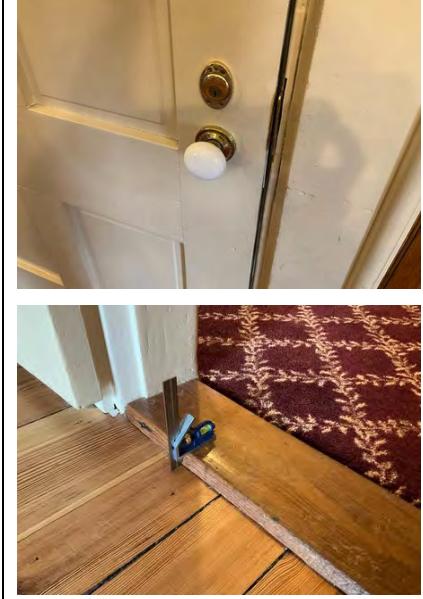
7.	<p>Doors (Typical)</p> <p>The door hardware requires tight grasping, pinching, or twisting of the wrist to operate.</p> <p>The threshold is >1/2", @ up to 1".</p>	2010 ADAS 404.2.7

<p>Replace the door hardware with lever type.</p> <p>Unit Cost: \$300</p> <p>Quantity: 12</p> <p>Replace the threshold.</p> <p>Unit Cost: \$250</p> <p>Quantity: 10</p>	\$6,100
8.	<p>Signage</p> <p>There is no tactile/Braille signage mounted on the latch side of the door.</p>	2010 ADAS 703.4.2

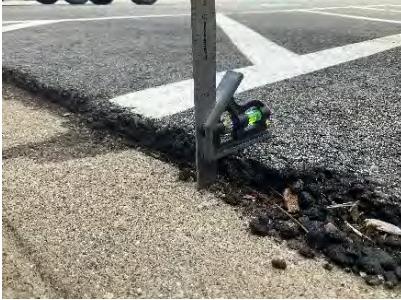
#	Barrier Statement	Code References	Photo	Proposed Mitigation	Cost
1.	Parking The walkway has abrupt changes of levels $>\frac{1}{4}$ " and $<\frac{1}{2}$ " and is not beveled 1:2 where two materials meet or due to areas of deterioration/material settlement, @ 1".	2010 ADAS 403.4

Regrade the concrete walkway to be flush with the asphalt driveway. Unit Cost: \$25/SF Quantity: 30 SF	\$750
2.	Public Entrance The door lacks a level landing, @ 3.5%.	2010 ADAS 404.2.4.4

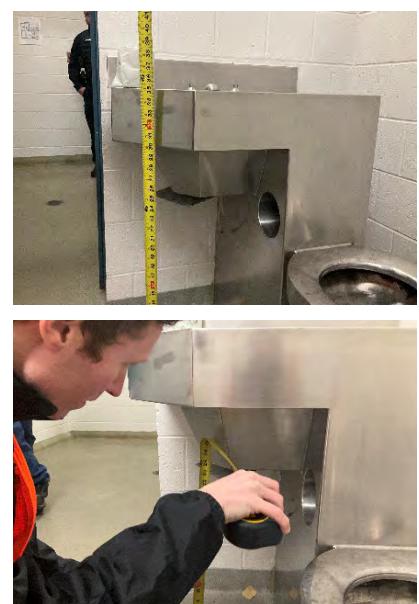
<p>Lower the mirror. Unit Cost: \$50 ea. Quantity: 1</p> <p>Relocate the dispenser. Unit Cost: \$50 ea. Quantity: 1</p>	\$100
4.	<p>Detention Cell</p> <p>The lavatory/toilet unit lacks the required 27" high min. knee clearance, @ 24".</p>	<p>2010 ADAS 307.2</p>

<p>Replace the lavatory/toilet unit. Unit Cost: \$3,000 ea. Quantity: 1</p>	\$3,000

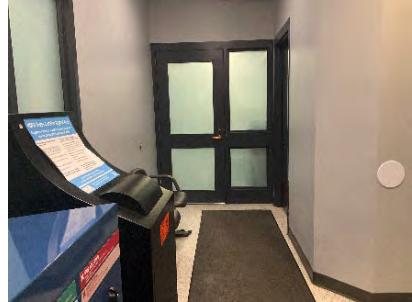
5.	Signage There is no tactile/Braille signage mounted on the latch side of the door.	2010 ADAS 703.4.2

Install tactile/Braille signage on the latch side of the door. Coordinate with location and height requirements. Unit Cost: \$100 ea. Quantity: 3	\$300
TOTAL FOR POLICE STATION:					\$5,150

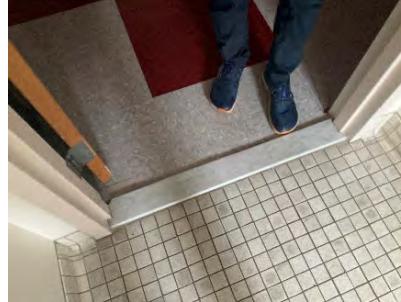
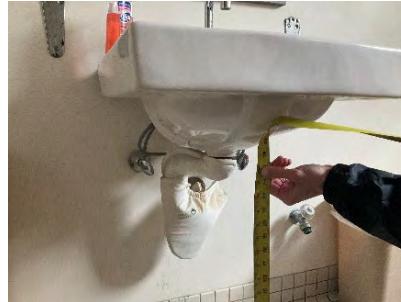
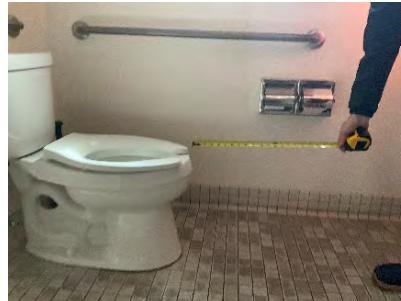
9.	<p>Single-User Toilet Room</p> <p>The threshold is $>\frac{1}{4}$" high and $<\frac{1}{2}$" and not beveled at 1:2, or the material transition is $>\frac{1}{4}$" high.</p> <p>The bottom of the reflective surface of the mirror is >40" AFF, @ 41".</p> <p>The lavatory lacks the required 27" high min. knee clearance, @ 25".</p> <p>The toilet paper dispenser is not located 7"-9" from the front of the toilet, @ 13".</p>	<p>2010 ADAS 404.2.5 2010 ADAS 603.3 2010 ADAS 307.2 2010 ADAS 604.7</p>

<p>Replace the threshold or material transition. Unit Cost: \$250 ea. Quantity: 1</p> <p>Lower the mirror. Unit Cost: \$50 ea. Quantity: 1</p> <p>Modify the lavatory. Unit Cost: \$750 ea. Quantity: 1</p> <p>Relocate the toilet paper dispenser. Unit Cost: \$50 ea. Quantity: 1</p>	\$1,100
TOTAL FOR FIRE STATION:					\$5,050

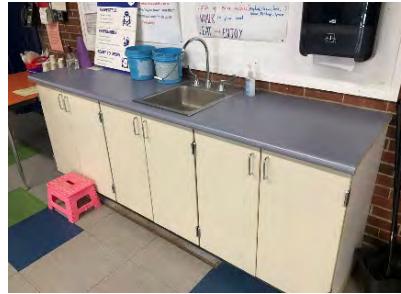
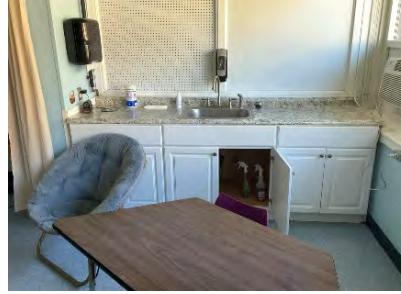
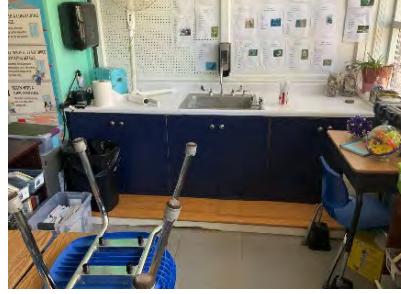
<p>Relocate the AED cabinet.</p> <p>Unit Cost: \$50 ea.</p> <p>Quantity: 2</p>	\$100
14.	<p>Sinks Inside Cafeteria and Classrooms (C Wing)</p> <p>The sink lacks the required knee/toe clearance for a forward approach.</p> <p>The sink and counters are >34" AFF, @ 34 1/2".</p> <p><i>Observed in Room 21 C only.</i></p>	<p>2010 ADAS 606.2</p> <p>2010 ADAS 606.3</p>

<p>Retrofit at least one sink in the cafeteria and each type of classroom.</p> <p>Unit Cost: \$750 ea.</p> <p>Quantity: 8</p>	\$6,000

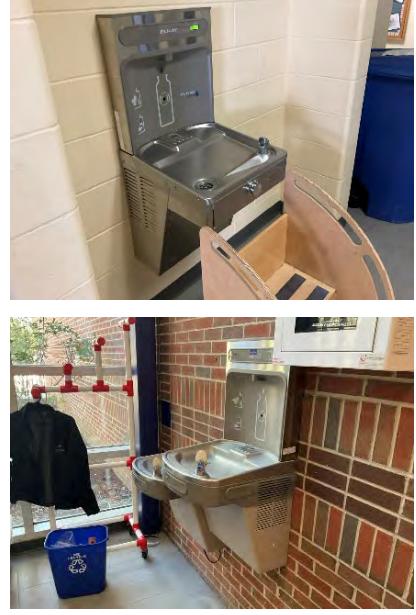
15.	<p>Drinking Fountains</p> <p>There is no high drinking fountain for standing persons provided.</p> <p><i>Observed at drinking fountain near the main entrance.</i></p> <p>The drinking fountain protrudes >4" into the circulation space, @ up to 19 1/2".</p> <p><i>Observed at drinking fountains near the main entrance and outside of the gymnasium.</i></p>	<p>2010 ADAS 211.2</p> <p>2010 ADAS 307.2</p>

<p>Install a second drinking fountain for standing persons.</p> <p>Unit Cost: \$1,000 ea.</p> <p>Quantity: 1</p> <p>Install partition walls on both sides of the drinking fountains.</p> <p>Unit Cost: \$250 ea.</p> <p>Quantity: 2</p>	\$1,500

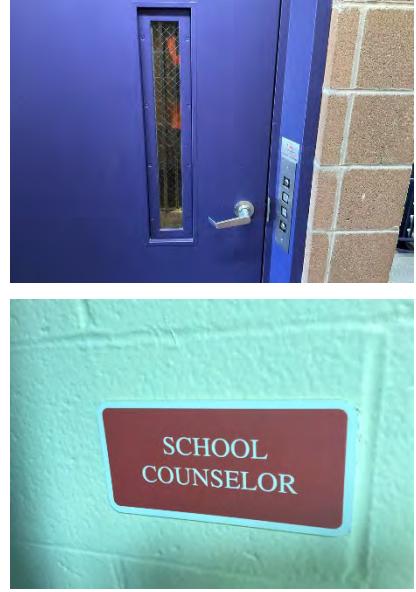
16.	<p>Signage</p> <p>There is no tactile/Braille signage mounted on the latch side of the door.</p>	2010 ADAS 703.4.2

<p>Install tactile/Braille signage on the latch side of the door. Coordinate with location and height requirements.</p> <p>Unit Cost: \$100 ea.</p> <p>Quantity: 2</p>	\$200

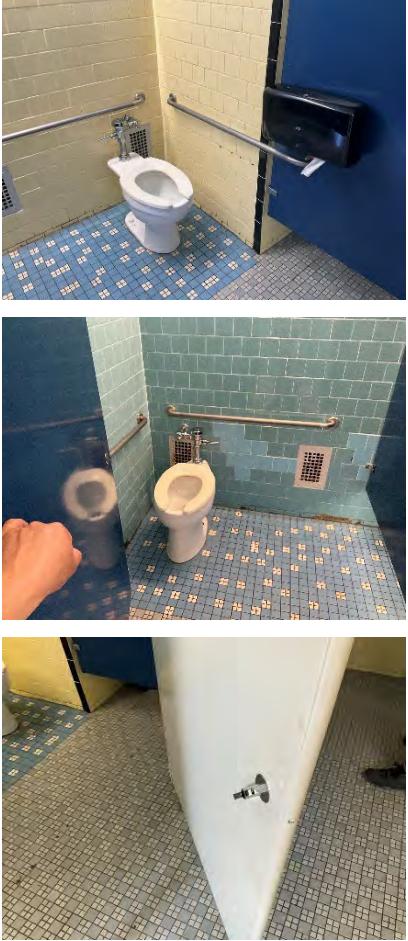
17.	<p>Boys' and Girl's Multi-user Toilet Room (C Wing)</p> <p>The grab bars are not mounted 18"-27" AFF, measured to the top of the gripping surface, @ 30 1/2".</p> <p>A pull device is not provided on both sides of the stall door.</p> <p>The toilet paper dispenser is located >7"-9" from the front of the toilet, @ up to 21".</p> <p>The door swings into the minimum required compartment area.</p> <p><i>Observed in Boys' only.</i></p> <p>The dispenser is located <12" above the grab bar, @ 4 1/2".</p>	<p>2010 ADAS 609.4 2010 ADAS 604.8.1.2 2010 ADAS 604.7 2010 ADAS 604.8.1.2 2010 ADAS 609.3</p>

<p>Reposition the grab bars. Unit Cost: \$50 ea. Quantity: 4</p> <p>Install pull devices on both sides of the door, near the latch. Unit Cost: \$250 ea. Quantity: 2</p> <p>Relocate the toilet paper dispenser. Unit Cost: \$50 ea. Quantity: 2</p> <p>Reverse the swing of the door. Unit Cost: \$100 ea. Quantity: 1</p> <p>Relocate the toilet paper dispenser. Unit Cost: \$50 ea. Quantity: 2</p>	\$1,000

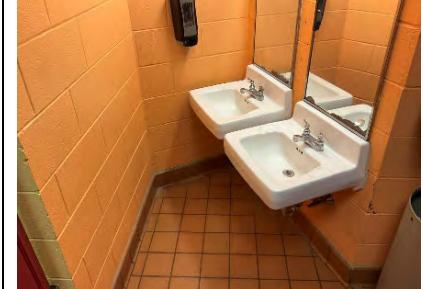
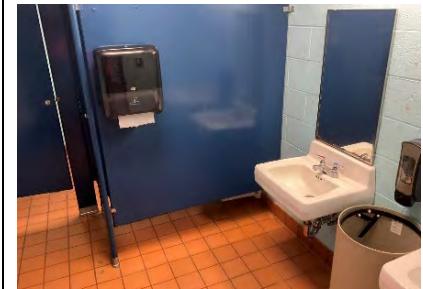
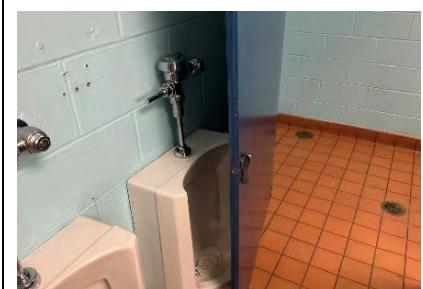
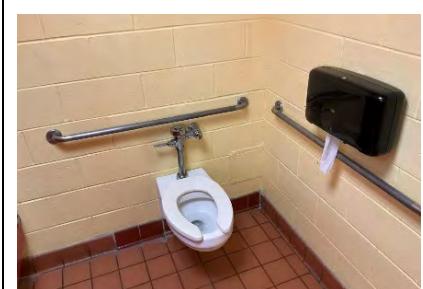
18.	<p>Men's and Women's Multi-user Toilet Room in Library (D Wing)</p> <p>The lavatory lacks clear floor space for a forward approach.</p> <p>The pipes underneath the lavatory are not insulated.</p> <p>The toilet centerline is not 16"-18" from the adjacent side wall, @ 24".</p> <p>The grab bars do not provide the required clearances, @ 1", due to the flush valve.</p> <p>The dispenser is located <12" above the grab bar, @ 4 1/2".</p> <p><i>Observed in the Women's only.</i></p> <p>The toilet paper dispenser is located <7"-9" from the front of the toilet.</p> <p>The stall door is obstructed by the urinal.</p> <p>The lavatory lacks the required 27" high min. knee clearance, @ 25".</p> <p>The lavatory lacks the required clear floor space for a forward approach.</p> <p><i>Observed in the Women's only.</i></p> <p>The bottom of the reflective surface of the mirror is >40" AFF, @ 44".</p> <p>A pull device is not provided on both sides of the stall door.</p> <p>The paper towel dispenser protrudes >4" into the circulation space, @ 8".</p> <p>The coat hook is >48" AFF, @ 54".</p>	<p>2010 ADAS 606.2 2010 ADAS 606.5 2010 ADAS 604.2 2010 ADAS 609.3 2010 ADAS 609.4 2010 ADAS 404.2.4 2010 ADAS 606.2 2010 ADAS 306.3 2010 ADAS 604.8.1.2 2010 ADAS 307.2 2010 ADAS 604.8.3</p>

<p>Install insulation around the sink pipes. Unit Cost: \$100 ea. Quantity: 1</p> <p>Reposition the toilet. Unit Cost: \$1,500 ea. Quantity: 2</p> <p>Reposition the grab bars. Unit Cost: \$50 ea. Quantity: 4</p> <p>Relocate the toilet paper dispenser. Unit Cost: \$50 ea. Quantity: 2</p> <p>Relocate the urinal. Unit Cost: \$750 ea. Quantity: 1</p> <p>Modify the lavatory. Unit Cost: \$750 ea. Quantity: 2</p> <p>Install pull devices on both sides of the door, near the latch. Unit Cost: \$250 ea. Quantity: 2</p> <p>Relocate the paper towel dispenser. Unit Cost: \$50 ea. Quantity: 2</p> <p>Provide a coat hook mounted no higher than 48" AFF. Unit Cost: \$50 ea. Quantity: 2</p>	\$6,350

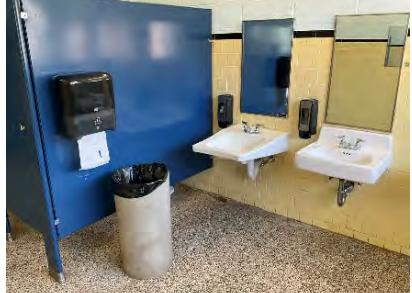
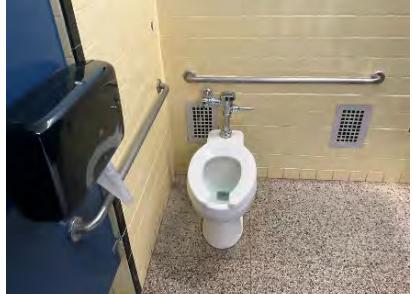
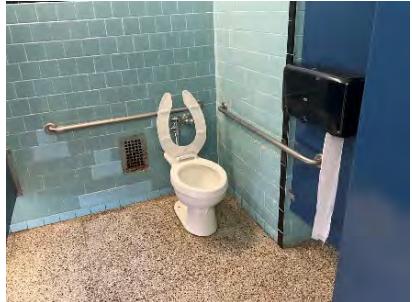
19.	<p>Boys' and Girl's Multi-user Toilet Room (A Wing)</p> <p>The grab bars are not mounted 18"-27" AFF, measured to the top of the gripping surface, @ 29 1/2".</p> <p>A pull device is not provided on both sides of the stall door.</p> <p>The toilet paper dispenser is located >7"-9" from the front of the toilet, @ up to 15".</p> <p><i>Observed in Boy's only.</i></p> <p>The dispenser is located <12" above the grab bar, @ 7".</p> <p><i>Observed in the Women's Room only.</i></p> <p>The door swings into the minimum required compartment area.</p> <p><i>Observed in Boys Room only.</i></p> <p>The coat hook is >48" AFF, @ 53".</p> <p>The paper towel dispenser protrudes >4" into the circulation space, @ 8".</p>	<p>2010 ADAS 609.4 2010 ADAS 604.8.1.2 2010 ADAS 604.7 2010 ADAS 609.3 2010 ADAS 604.8.3 2010 ADAS 307.2</p>

<p>Reposition the grab bars. Unit Cost: \$50 ea. Quantity: 4</p> <p>Install pull devices on both sides of the door, near the latch. Unit Cost: \$250 ea. Quantity: 2</p> <p>Relocate the toilet paper dispenser. Unit Cost: \$50 ea. Quantity: 2</p> <p>Reverse the swing of the door. Unit Cost: \$100 ea. Quantity: 1</p> <p>Provide a coat hook mounted no higher than 48" AFF. Unit Cost: \$50 ea. Quantity: 2</p> <p>Relocate the paper towel dispenser. Unit Cost: \$50 ea. Quantity: 2</p>	\$1,100

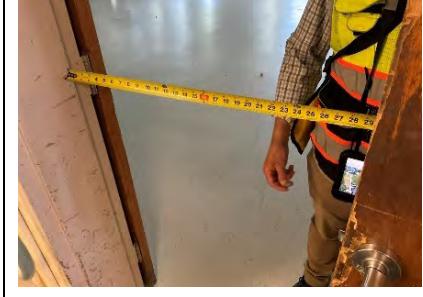
7.	<p>Doors</p> <p>The door provides <32" clear width, @ 28".</p> <p><i>Observed in the Band Room and entrance to auditorium's front row seating.</i></p>	2010 ADAS 404.2.3

<p>Replace the door with a wider door.</p> <p>Unit Cost: \$1,000 ea.</p> <p>Quantity: 4</p>	\$4,000

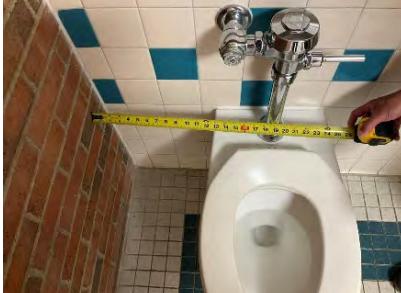
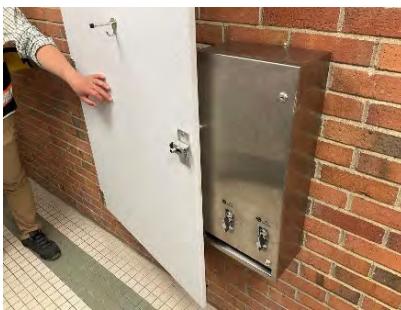
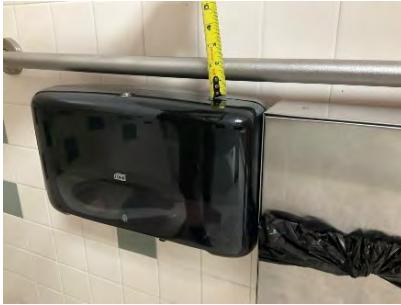
9.	<p>Men's and Women's Multi-User Toilet Rooms</p> <p>The bottom of the reflective surface of the mirror is >40" AFF, @ 40 ½".</p> <p>The toilet centerline is not 16"-18" from the nearest adjacent side wall, @ 18 ¾".</p> <p><i>Observed in Men's only.</i></p> <p>The toilet stall door lacks a pull device on both sides of the door.</p> <p>The coat hooks are mounted >48" AFF, @ 53".</p> <p>The accessible stall doors lack a self-closing device.</p> <p>The door maneuvering clearance are not provided on both sides of the swing of the door, due to the feminine hygiene dispenser.</p> <p><i>Observed in Women's only.</i></p> <p>The toilet paper dispenser is <1 ½" below the grab bar, @ 1".</p>	<p>2010 ADAS 603.3</p> <p>2010 ADAS 604.2</p> <p>2010 ADAS 604.8.1.2</p> <p>2010 ADAS 604.8.3</p> <p>2010 ADAS 604.8.1.2</p> <p>2010 ADAS 404.2.3</p> <p>2010 ADAS 609.3</p>

<p>Lower the mirror. Unit Cost: \$50 ea. Quantity: 2</p> <p>Reposition the toilet. Unit Cost: \$1,500 ea. Quantity: 1</p> <p>Install a door pull on both sides of the stall door. Unit Cost: \$50 ea. Quantity: 2</p> <p>Install a coat hook mounted no higher than 48" AFF. Unit Cost: \$50 ea. Quantity: 2</p> <p>Install a self-closing door. Unit Cost: \$50 ea. Quantity: 2</p> <p>Relocate the feminine hygiene dispenser. Unit Cost: \$50 ea. Quantity: 1</p> <p>Relocate the toilet paper dispenser. Unit Cost: \$50 ea. Quantity: 2</p>	\$2,050

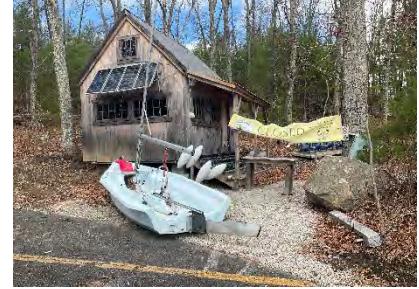
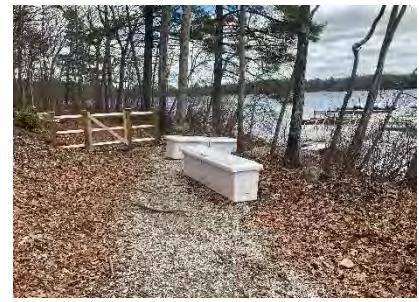
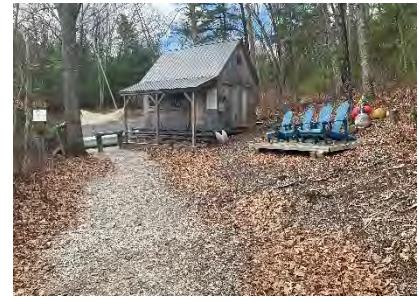
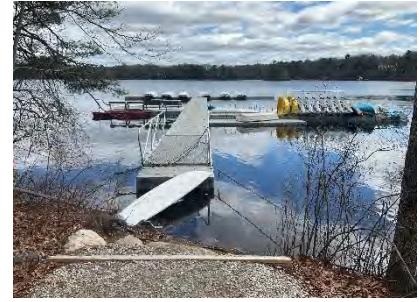
4.	<p>Access to Boat Slips</p> <p>There is no accessible route to the boat slips due to the surface condition and excessive slopes and the lack of a compliant gangway.</p>	2010 ADAS 206.1

<p>Provide an accessible route between the accessible parking space and boat slips. Additional study required.</p> <p>Unit Cost: \$25/SF Est. Quantity: 640 SF</p>	\$16,000
----	---	-----------------	--	--	----------
