Appendix B. Physical Environment Audit

This Appendix includes three sections from [KMA](#), the project team's physical environment experts:

TOWN HALL

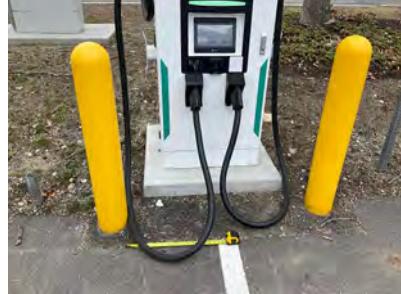
#	Barrier Statement	Code References	Photo	Proposed Mitigation	Cost
1.	EV Charging Station The EV charging station lacks the required 30"x48" minimum clear floor space adjacent to it, @ 24" clear floor space, and has slopes >2%, @ 2.6%.	2010 ADAS 309.2 2010 ADAS 305.2

Provide the required clear floor space adjacent to the EV charging station. Unit Cost: \$1,000 ea. Quantity: 1	\$1,000
2.	Ramp to Accessible Entrance The running slope of the ramp is >8.3%, @ up to 9.2%. The edge protection curb or barrier does not prevent the passage of a 4" min. sphere, @ 8".	2010 ADAS 405.2 2010 ADAS 405.9.2

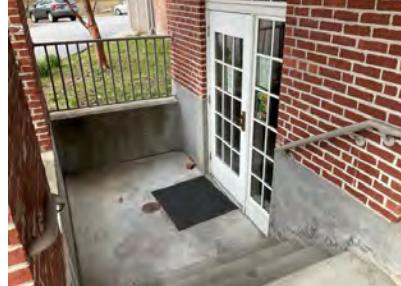
3.	Rear Entrance The threshold is $>\frac{1}{4}$ " high and $<\frac{1}{2}$ ", and is not beveled at 1:2. Directional signage is not provided at the non-accessible entrance.	2010 ADAS 404.2.5 2010 ADAS 216.6

Replace the threshold. Unit Cost: \$250 ea. Quantity: 1 Provide directional signage to the nearest accessible entrance. Unit Cost: \$150 ea. Quantity: 1	\$400

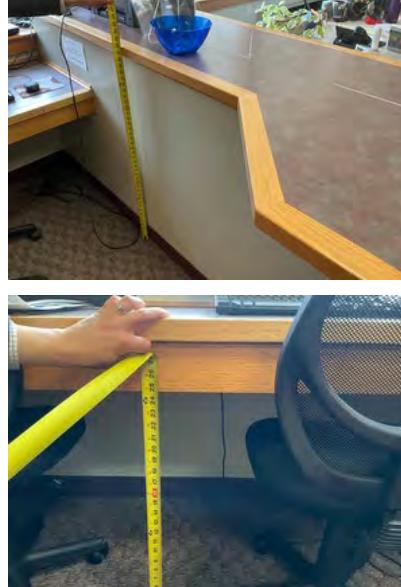
5.	Assessor's Office 102 (First Floor) The accessible portion of the counter is >36 " AFF, @ 42". The dining/work surface lacks the required knee/toe clearances, @ 24 1/2".	2010 ADAS 904.4.1 2010 ADAS 902.2

Provide a 36" wide lower portion of the counter at 36" AFF max. Unit Cost: \$750 ea. Quantity: 1 Provide at least one dining/ work surface, and no less than 5% of the total number of dining/ work surface, that provides compliant knee and toe clearance. Unit Cost: \$250 ea. Quantity: 1	\$1,000

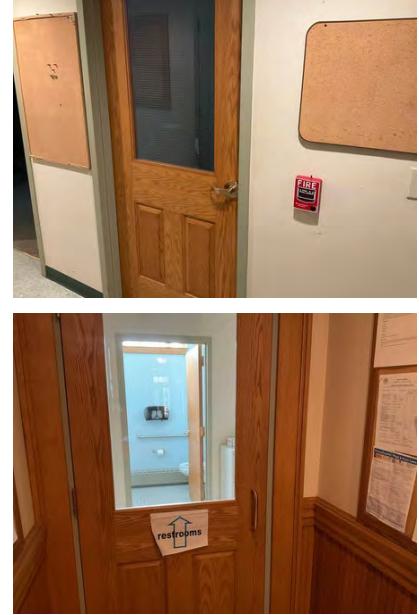
8.	<p>Signage (Typical)</p> <p>There is no tactile/Braille signage mounted on the latch side of the door.</p>	2010 ADAS 703.4.2

<p>Install tactile/Braille signage on the latch side of the door. Coordinate with location and height requirements.</p> <p>Unit Cost: \$100 ea.</p> <p>Quantity: 20</p>	\$2,000
9.	<p>Second Floor Staff Room</p> <p>The sink and counters are >34" AFF, @ 36".</p>	2010 ADAS 804.3.2

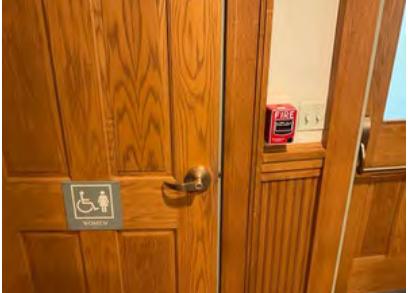
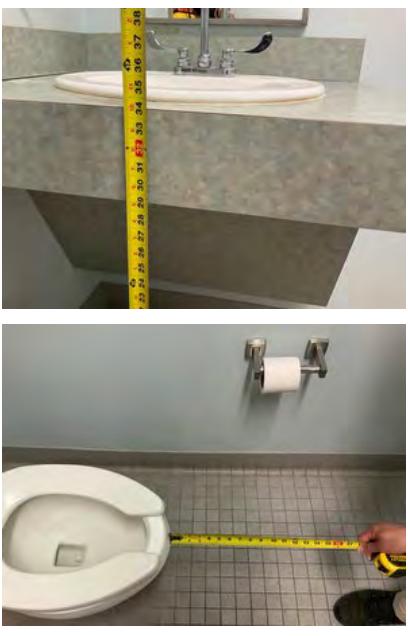
12.	Men's & Women's Single-user Toilet Room (Second Floor) <p>The door maneuvering clearance are not provided on both sides of the swing of the door.</p> <p>The lavatory is mounted >34" AFF, @ 34 1/2".</p> <p>The toilet lacks the required clearance around it, @ up to 47 1/2".</p> <p>The toilet paper dispenser is not located 7"-9" from the front of the toilet, @ 11".</p> <p>The grab bars are not mounted 33"-36" AFF, measured to the top of the gripping surface, @ 37".</p> <p>The toilet paper dispenser is located <12" above the grab bar, @ 9".</p> <p>The paper towel dispenser is mounted >48" AFF, @ 51".</p> <p>The coat hook is >48" AFF, up to 65".</p>	2010 ADAS 404.2.4.1 2010 ADAS 606.3 2010 ADAS 604.3 2010 ADAS 604.7 2010 ADAS 609.3 2010 ADAS 308.3.1 2010 ADAS 604.8.3

Install an automatic door opener. Unit Cost: \$2,500 ea. Quantity: 2 Lower and modify the lavatory. Unit Cost: \$750 ea. Quantity: 2 Relocate the toilet paper dispenser. Unit Cost: \$50 ea. Quantity: 2 Reposition the grab bars. Unit Cost: \$50 ea. Quantity: 4 Remove the toilet paper dispenser above the grab bar. Unit Cost: \$50 ea. Quantity: 2 Relocate the toilet paper dispenser. Unit Cost: \$50 ea. Quantity: 2 Provide a coat hook mounted no higher than 48" AFF. Unit Cost: \$50 ea. Quantity: 2	\$7,100

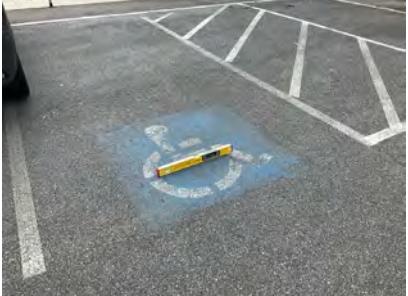
#	Barrier Statement	Code References	Photo	Proposed Mitigation	Cost
1.	<p>Parking along Sanger Street</p> <p>The designated accessible parking spaces and their associated access aisles have slopes >2%, @ up to 4.2%.</p>	2010 ADAS 502.4

<p>Regrade and restripe the existing designated parking spaces and their associated access aisles.</p> <p>Unit Cost: \$1,500 ea.</p> <p>Quantity: 3 (2 spaces, 1 aisle)</p>	\$3,000
2.	<p>Walkway Between Accessible Parking and Main Entrance</p> <p>The walkway has running slopes >5%, @ up to 7.6%, and is not treated as a ramp.</p> <p>The walkway has cross slopes >2%, @ up to 4.1%.</p>	2010 ADAS 403.3

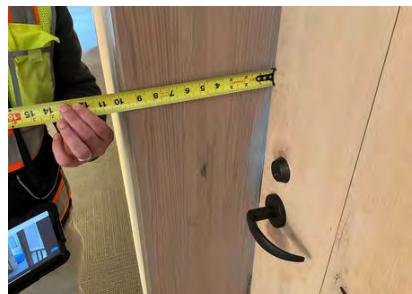
5.	Doors to Study Room (Second Floor) <p>The door is located in a recess >8" and the push side door maneuvering clearance is <48" perpendicular to the door for a front approach.</p>	2010 ADAS 404.2.4.3

<p>Relocate the pivot hinges.</p> <p>Unit Cost: \$500 ea.</p> <p>Quantity: 1</p>	\$500

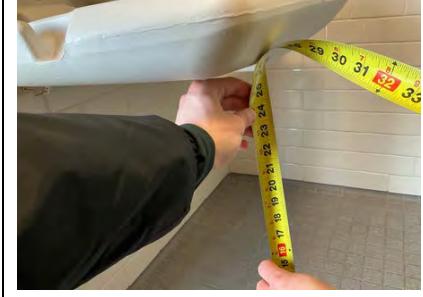
9.	<p>Single-User Toilet Room at Children's Room (First Floor)</p> <p>The baby changing station does not provide the required knee clearance. @ 26".</p>	2010 ADAS 902.2

<p>Raise the baby changing station. Unit Cost: \$50 ea. Quantity: 1</p>	\$50
10.	<p>Single-User Toilet Room (Second Floor)</p> <p>The threshold is $>\frac{1}{4}$" high and $<\frac{1}{2}$" and not beveled at 1:2, or the material transition is $>\frac{1}{4}$" high.</p> <p>The lavatory is mounted >34" AFF, @ 34 $\frac{1}{4}$".</p>	2010 ADAS 404.2.5 2010 ADAS 606.3

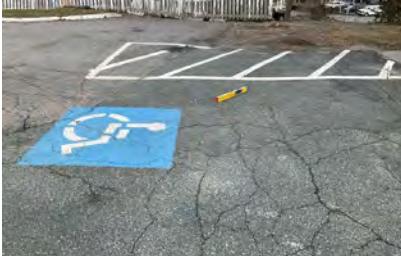
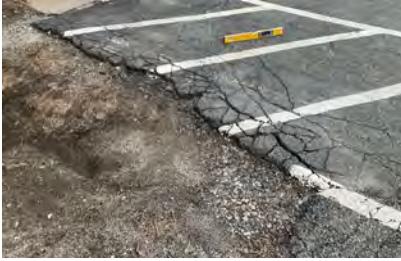
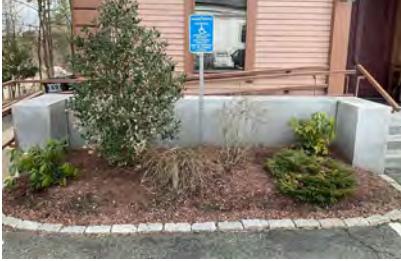
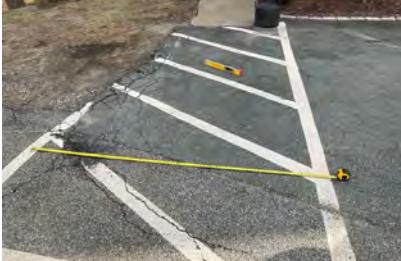
#	Barrier Statement	Code References	Photo	Proposed Mitigation	Cost
1.	<p>Parking</p> <p>The designated accessible parking spaces and their associated access aisles have slopes >2%, @ 3.7%.</p> <p>The designated accessible parking space and/or their associated access aisle has abrupt changes in level.</p> <p>There is an insufficient number of van accessible parking spaces. The existing accessible parking spaces do not meet the dimensional requirements for a van space.</p> <p>The access aisle is <60" wide, measured centerline to centerline.</p>	<p>2010 ADAS 502.4</p> <p>2010 ADAS 208.2.4</p> <p>2010 ADAS 502.3.1</p>

<p>Regrade and restripe the existing designated parking spaces and their associated access aisles.</p> <p>Unit Cost: \$1,500 ea.</p> <p>Quantity: 2 (1 space, 1 aisle)</p> <p>Install a “van accessible” sign at 60" min. AFF, measured to the bottom of the sign.</p> <p>Unit Cost: \$100 ea.</p> <p>Quantity: 1</p>	\$3,100

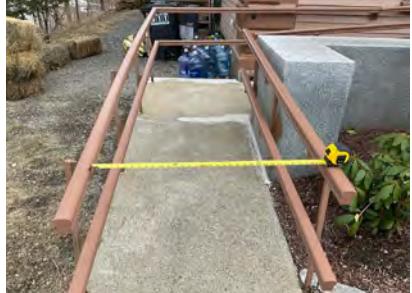
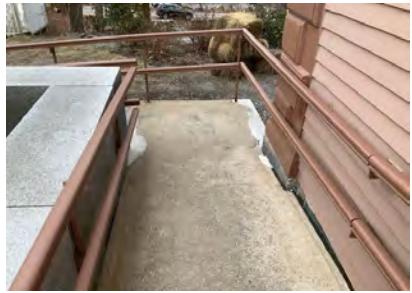
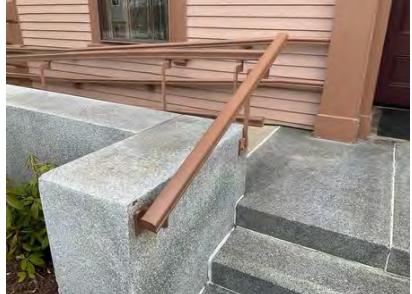
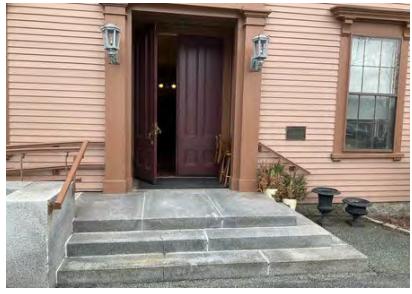
- Priorities (Year 1)	KMA recommends prioritizing the ramp and stairs leading to the accessible entrance, limited-use/limited-application elevator, toilet rooms, and the Great Hall due to their high visibility in the first year of mitigation

2.	<p>Ramp and Stairs to Entrance</p> <p>The running slope of the ramp is >8.3%, @ 10%.</p> <p>The ramp is <36" wide measured between handrails, @ 33 1/2".</p> <p>The ramp has an abrupt transition to the adjacent floor/ground surface.</p> <p>The edge protection curb or barrier along the ramp does not prevent the passage of a 4" min. sphere.</p> <p>The ramp handrail perimeter is not 4"-6 1/4" for a non-circular cross-section, @ 8".</p> <p>The clear space between the ramp handrail and the adjacent surface is <1 1/2", @ 1/2".</p> <p>The ramp handrails do not return to a wall, guard, or landing surface.</p> <p>The stairs handrail perimeter is not 4"-6 1/4" for a non-circular cross-section, @ 8 1/2".</p> <p>The stair lacks the required handrail extensions at the top and bottom of the stair flight.</p>	<p>2010 ADAS 405.2</p> <p>2010 ADAS 405.5</p> <p>2010 ADAS 405.4</p> <p>2010 ADAS 405.9.2</p> <p>2010 ADAS 505.7.2</p> <p>2010 ADAS 505.5</p> <p>2010 ADAS 505.10.1</p> <p>2010 ADAS 505.7.2</p> <p>2010 ADAS 505.10.2 & 505.10.3</p>

<p>Rebuild the ramp. Unit Cost: \$15,000 ea. Quantity: 1</p> <p>Install compliant handrails on both sides of the stair. Unit Cost: \$50/LF Est. Quantity: 12 LF</p>	\$15,600

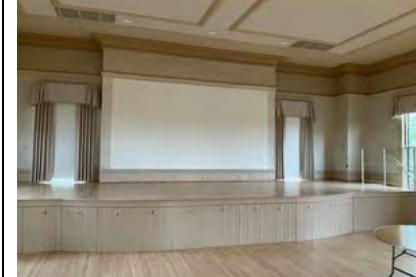
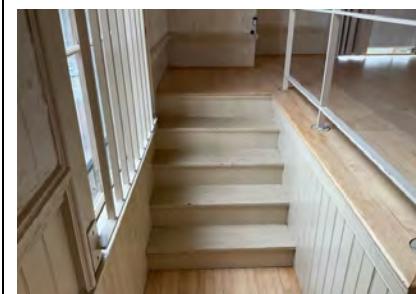
5.	<p>Great Hall (Second Floor)</p> <p>Both stairs to the stage do not have handrails on both sides.</p> <p>The handrails do not return to a wall, guard, or landing surface.</p> <p>The performance area is not located on an accessible route.</p> <p>An assistive listening system is not provided.</p> <p>Signs informing patrons of the availability of the assistive listening system are not provided.</p>	<p>2010 ADAS 505.2</p> <p>2010 ADAS 505.10.2-3</p> <p>2010A DAS 206.2.6</p> <p>2010 ADAS 216.10</p>

<p>Install compliant handrails on both sides of the stair.</p> <p>Unit Cost: \$50 /LF</p> <p>Est. Quantity: 28 LF</p> <p>Provide an accessible route to the performance area.</p> <p>Unit Cost: \$5,000 ea.</p> <p>Quantity: 1</p> <p>Provide an assistive listening system.</p> <p>Unit Cost: \$10,000 ea.</p> <p>Quantity: 1</p> <p>Install tactile/Braille signage to inform patrons. Coordinate with location and height requirements.</p> <p>Unit Cost: \$100 ea.</p> <p>Quantity: 1</p>	\$16,500

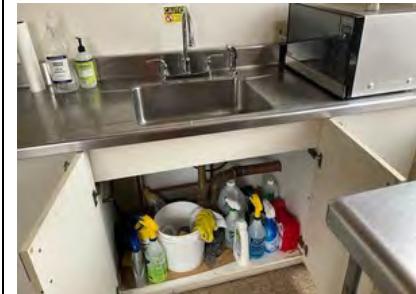
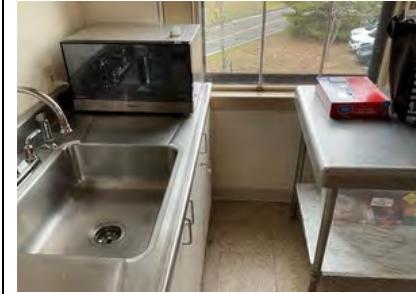
6.	<p>Kitchen (Second Floor)</p> <p>The sink and counters are >34" AFF, @ 36".</p> <p>The appliances lack the required 36"x48" clear floor space adjacent to it.</p>	<p>2010 ADAS 804.3.2</p> <p>2010 ADAS 804.6.1</p>

<p>Lower the sink and counters to 34" AFF max.</p> <p>Unit Cost: \$3,000 ea.</p> <p>Quantity: 1</p> <p>Modify the layout to provide the required centered approach to the appliances.</p> <p>Unit Cost: \$750 ea.</p> <p>Quantity: 1</p>	\$3,750

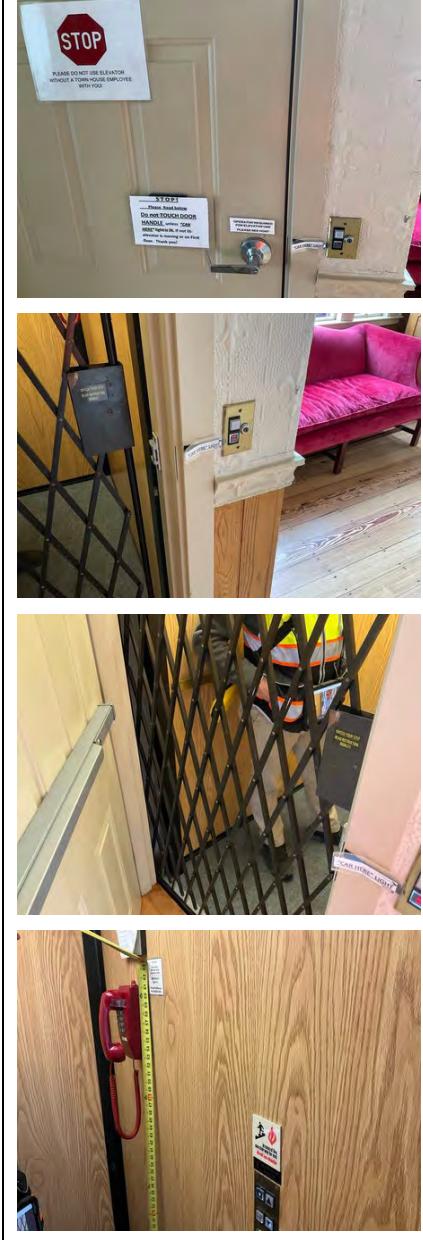
9.	<p>Limited-Use/Limited Application (LU/LA) Elevator</p> <p>The LU/LA elevator is not independently operable, per sign.</p> <p>The sliding door does not reopen automatically when obstructed, and remains open for <20 seconds when activated.</p> <p>The LU/LA elevator door is not power-operated.</p> <p>The LU/LA elevator cab does not meet the minimum size dimensions, @ 50" x 36".</p> <p>In-car controls are not designated with raised characters and Braille.</p> <p>There are no audible signals which sound as the car passes or is about to stop at a floor.</p> <p>Emergency communication controls are mounted >54" AFF, @ 58 ½".</p> <p>There are no tactile/Braille signage mounted on both jambs of the LU/LA elevator hoistway entrances.</p>	<p>2010 ADAS 206.6</p> <p>2010 ADAS 408.3</p> <p>2010 ADAS 408.3.2.1</p> <p>2010 ADAS 408.3.2.2</p> <p>2010 ADAS 408.4.1</p> <p>2010 ADAS 408.4.7</p> <p>2010 ADAS 408.4.8</p> <p>2010 ADAS 408.2.2</p>

<p>Modernize the LU/LA elevator. Further study required to enlarge the dimensions of the elevator cab.</p> <p>Unit Cost: \$50,000</p> <p>Quantity: 1</p>	\$50,000

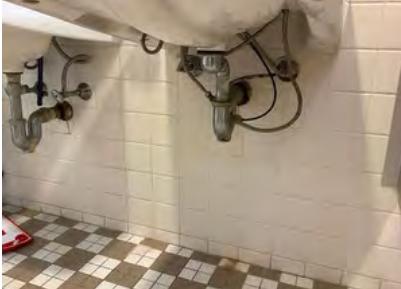
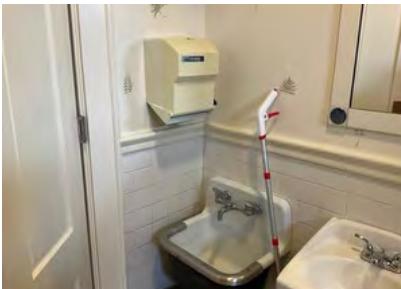
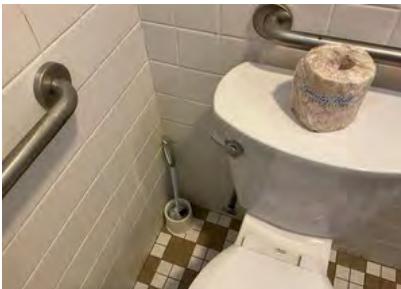
10.	Men's and Women's Multi-User Toilet Room (First Floor) <p>The door maneuvering clearance are not provided on both sides of the swing of the door.</p> <p>The threshold is $>\frac{1}{4}$" high and $<\frac{1}{2}$" and not beveled at 1:2, or the material transition is $>\frac{1}{4}$" high.</p> <p>The pipes underneath the lavatory/sink are not insulated.</p> <p>The bottom of the reflective surface of the mirror is >40" AFF, @ 55".</p> <p>The stall door lacks the required maneuvering clearances.</p> <p>The side grab bar is <42" long, @ 36".</p> <p>The rear grab bar extends <12" from the centerline of the toilet, @ 6".</p> <p>The dryers and dispensers are mounted >48" AFF, @ 51".</p> <p>The toilet flush control is not located on the wide side of the toilet.</p> <p><i>Observed in Women's only.</i></p>	2010 ADAS 404.2.4.1 2010 ADAS 404.2.5 2010 ADAS 606.5 2010 ADAS 603.3 2010 ADAS 604.8.1.2 2010 ADAS 604.5.1 2010 ADAS 604.5.2 2010 ADAS 308.3.1 2010 ADAS 604.6

<p>Install an automatic door opener. Unit Cost: \$2,500 Quantity: 2</p> <p>Replace the threshold or material transition. Unit Cost: \$250 Quantity: 2</p> <p>Install insulation around the sink pipes. Unit Cost: \$100 Quantity: 2</p> <p>Lower the mirror. Unit Cost: \$50 Quantity: 2</p> <p>Relocate the stall door. Unit Cost: \$900 Quantity: 2</p> <p>Provide a 42" min. side grab bar located 12" from the interior corner of the wall. Unit Cost: \$50 Quantity: 2</p> <p>Relocate the rear grab bar. Unit Cost: \$50 Quantity: 2</p> <p>Relocate the dispenser. Unit Cost: \$50 Quantity: 2</p> <p>Reposition the flush valve or install an automatic flush control. Unit Cost: \$1,500 Quantity: 1</p>	\$9,400

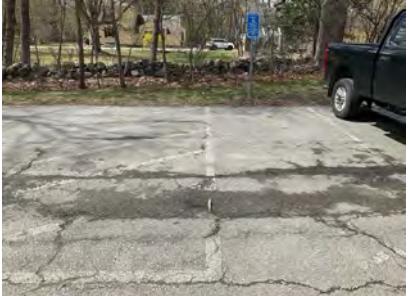
#	Barrier Statement	Code References	Photo	Proposed Mitigation	Cost
1.	Parking The designated accessible parking space and/or their associated access aisle has abrupt changes in level.	2010 ADAS 502.4

Resurface the existing designated parking spaces and/or their associated access aisles. Unit Cost: \$150 ea. Quantity: 2 (1 space, 1 aisle)	\$300
1.	Entrance The door is located in a recess >8" @ 13 1/4" and the push side door maneuvering clearance is <48" perpendicular to the door for a front approach.	2010 ADAS 404.2.4.3

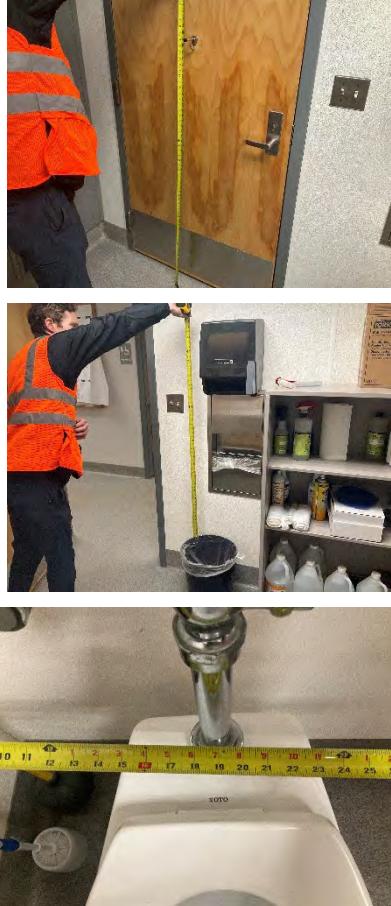
2.	<p>Single-user Toilet Room</p> <p>The coat hook is >48" AFF, @ up to 54".</p> <p>The paper towel dispenser is mounted >48" AFF, @ 50 1/2".</p> <p>The toilet centerline is not 16"-18" from the nearest adjacent side wall, @ 19", and the maneuvering clearance is obstructed by the bench.</p>	<p>2010 ADAS 604.8.3 2010 ADAS 308.2.1 2010 ADAS 604.2</p>

<p>Provide a coat hook mounted no higher than 48" AFF. Unit Cost: \$50 ea. Quantity: 1</p> <p>Relocate the paper towel dispenser. Unit Cost: \$50 ea. Quantity: 1</p> <p>Reposition the toilet. Unit Cost: \$500 ea. Quantity: 1</p>	\$600
TOTAL FOR PUBLIC WORKS BUILDING:					\$3,400

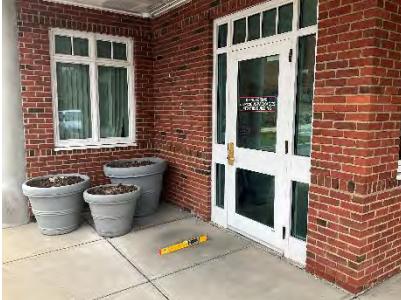
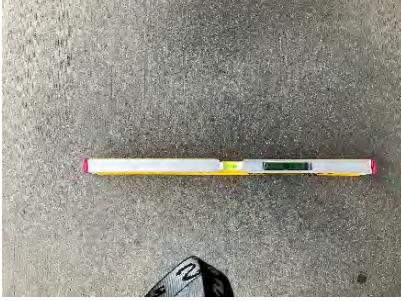
Regrade the concrete walkway to be flush with the asphalt driveway. Unit Cost: \$25/SF Quantity: 30 SF	\$750
2.	Public Entrance The door lacks a level landing, @ 3.5%.	2010 ADAS 404.2.4.4

Regrade the door landing. Unit Cost: \$1,000 ea. Quantity: 1	\$1,000

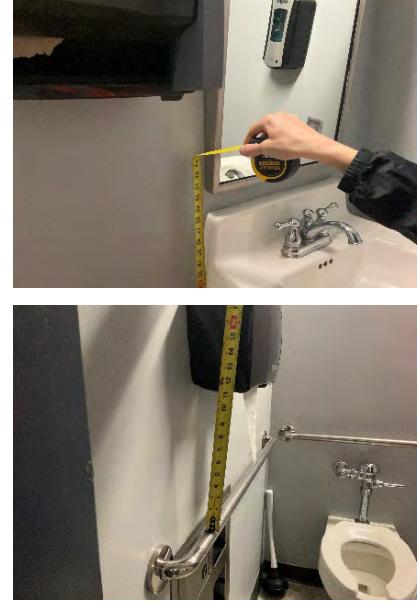
3.	<p>Single-User Toilet Room</p> <p>The bottom of the reflective surface of the mirror is >40" AFF, @ 41".</p> <p>The grab bar does not provide the required clearance due to the toilet paper dispenser <12" above the grab bar, @ 11".</p>	<p>2010 ADAS 603.3 2010 ADAS 609.3</p>

<p>Lower the mirror. Unit Cost: \$50 ea. Quantity: 1</p> <p>Relocate the dispenser. Unit Cost: \$50 ea. Quantity: 1</p>	\$100
4.	<p>Detention Cell</p> <p>The lavatory/toilet unit lacks the required 27" high min. knee clearance, @ 24".</p>	<p>2010 ADAS 307.2</p>

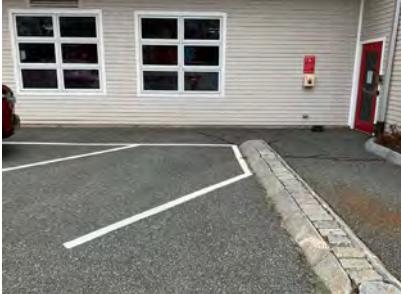
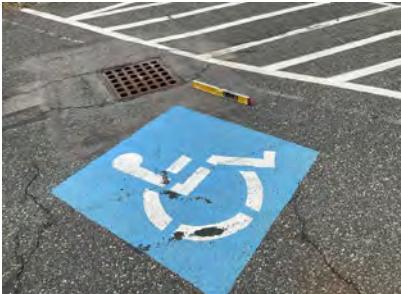
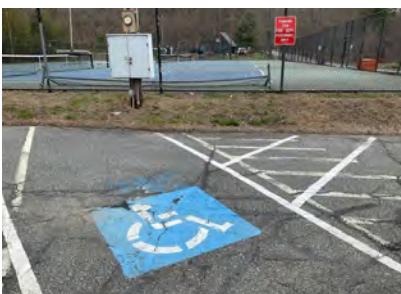
#	Barrier Statement	Code References	Photo	Proposed Mitigation	Cost
6.	<p>Parking</p> <p>The accessible parking spaces lack signs indicating they are accessible.</p> <p>The designated van accessible space lacks signage indicating it is van accessible.</p> <p>The designated accessible parking space nearest the entrance lacks an associated access aisle.</p> <p>The designated accessible parking spaces and their associated access aisles along Cemetery Lane have slopes >2%, @ 5.8%, due to the catch basin within the parking space.</p>	<p>2010 ADAS 502.6</p> <p>2010 ADAS 502.3</p> <p>2010 ADAS 502.4</p>

<p>Install signs (including a “van accessible” sign) at 60” min. AFF, measured to the bottom of the sign. Unit Cost: \$100 ea. Quantity: 2</p> <p>Stripe the pavement markings to provide an associated access aisle. Unit Cost: \$150 ea. Quantity: 1</p> <p>Regrade and restripe the existing designated parking spaces and their associated access aisles. Unit Cost: \$1,500 ea. Quantity: 2 (1 space, 1 aisle)</p>	\$3,350

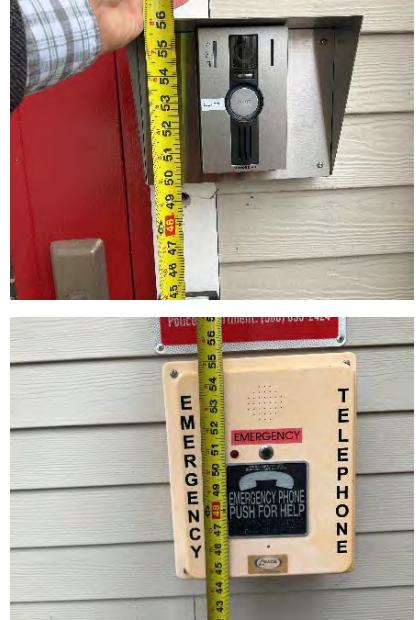
7.	<p>Entrance</p> <p>The operable parts of the intercom are not 15"-48" AFF, @ 53".</p> <p>The operable parts of the emergency phone are not 15"-48" AFF, @ 51".</p>	2010 ADAS 308.2.1

<p>Relocate the intercom and the emergency phone.</p> <p>Unit Cost: \$150 ea.</p> <p>Quantity: 2</p>	\$300
8.	<p>Signage</p> <p>There is no tactile/Braille signage mounted on the latch side of the door.</p>	2010 ADAS 703.4.2

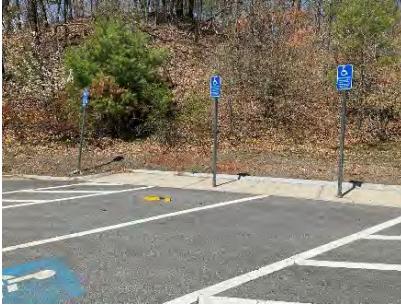
#	Barrier Statement	Code References	Photo	Proposed Mitigation	Cost
1.	Parking The designated accessible parking spaces and their associated access aisles have slopes >2%, @ up to 4%.	2010 ADAS 502.4

Regrade and restripe the existing designated parking spaces and their associated access aisles. Unit Cost: \$1,500 ea. Quantity: 3 (2 spaces, 1 aisle)	\$3,000
2.	Entryway Stairs The stair does not have handrails on both sides.	2010 ADAS 505.2

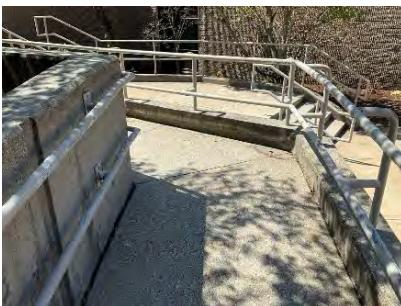
Install compliant handrails on both sides of the stair. Unit Cost: \$50/LF Est. Quantity: 6 LF	\$300
3.	Entry Ramp The running slope of the ramp is >8.3%, @ up to 9%. The ramp lacks a landing at the change of direction. The cross slope is >2, @ up to 4.1%.	2010 ADAS 405.2 2010 ADAS 405.7 2010 ADAS 405.3

Rebuild the ramp. Unit Cost: \$15,000 ea. Quantity: 1	\$15,000

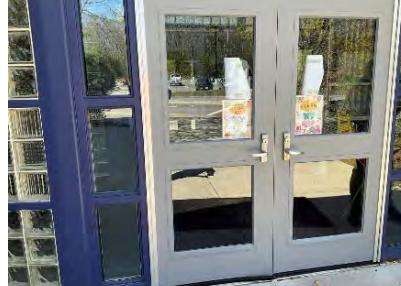
4.	<p>Entry Doors at Gymnasium</p> <p>The threshold is $> \frac{1}{2}$" high and not beveled at 1:2, @ $\frac{3}{4}$".</p>	2010 ADAS 404.2.5

<p>Replace the threshold. Unit Cost: \$250 ea. Quantity: 1</p>	\$250

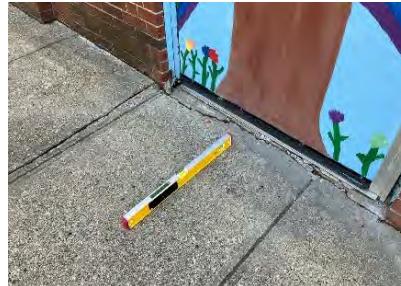
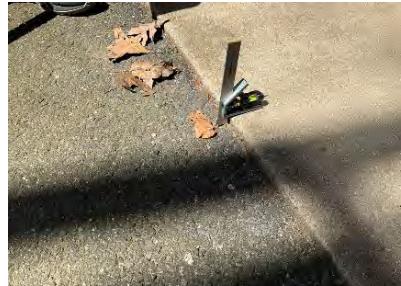
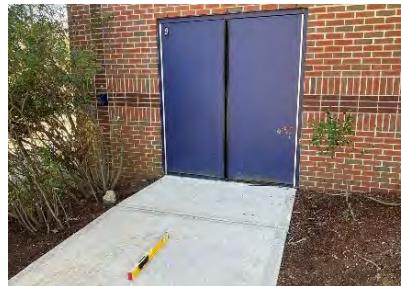
5.	<p>Egress Doors</p> <p>The door lacks a level landing, @ up to 4.2%.</p> <p><i>Observed at Door #2, and #20-#29.</i></p> <p>The threshold is $> \frac{1}{2}$" high and not beveled at 1:2, @ up to 1".</p> <p><i>Observed at Door #2 and #16.</i></p> <p>The door landing has an abrupt transition to the adjacent floor/ground surface, @ $\frac{3}{4}$".</p> <p><i>Observed at Door #25.</i></p> <p>The walkway has running slopes $>5\%$ and is not treated as a ramp, @ 7.1%.</p> <p><i>Observed at Door #9 and #30.</i></p>	2010 ADAS 404.2.4.4 2010 ADAS 404.2.5 2010 ADAS 405.4 2010 ADAS 307.2 2010 ADAS 403.3

<p>Regrade the door landing. Unit Cost: \$1,000 ea. Quantity: 9</p> <p>Replace the threshold. Unit Cost: \$250 Quantity: 1</p> <p>Replace the transition. Unit Cost: \$250 ea. Quantity: 1</p> <p>Regrade the walkway. Unit Cost: \$25/SF Est. Quantity: 40 SF</p>	\$10,500

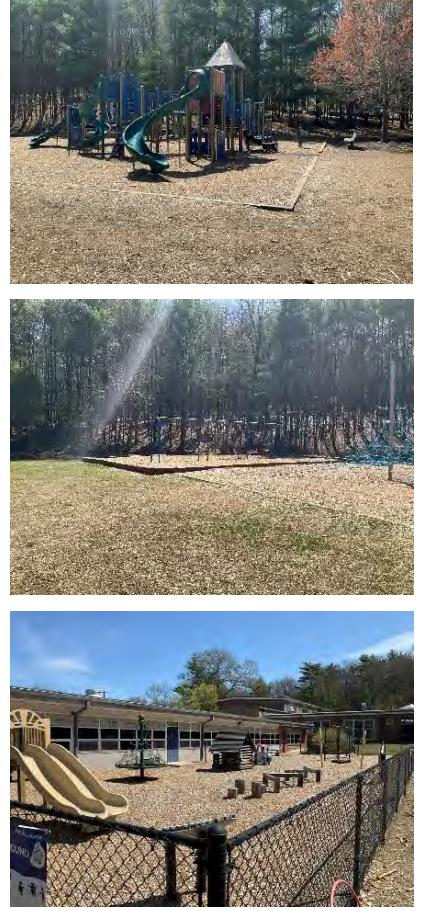
6.	<p>Playgrounds There is no accessible route to the play areas due to the wood fiber and/or lawn surface.</p>	<p>2010 ADAS 206.1 2010 ADAS 1008.2</p>

<p>Resurface the playground and provide at least one of each type of play area/component along an accessible route. Unit Cost: \$25/SF Est. Quantity: 2,000 SF</p>	\$50,000
7.	<p>Picnic Tables There is no accessible route to the picnic tables around the playgrounds.</p>	<p>2010 ADAS 206.1</p>

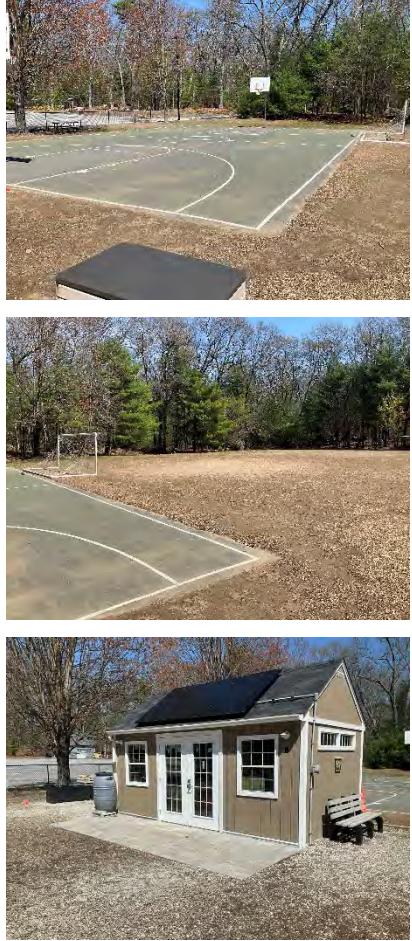
8.	<p>Basketball Court, Soccer Field and Shed</p> <p>An accessible route is not provided to the basketball court, the soccer field, or the shed.</p>	2010 ADAS 206.1

<p>Provide an accessible route between the walkway and the basketball court, one side of the soccer field, and to the entrance of the shed.</p> <p>Unit Cost: \$25/SF Est. Quantity: 150 SF</p>	\$3,750
----	--	-----------------	--	---	---------

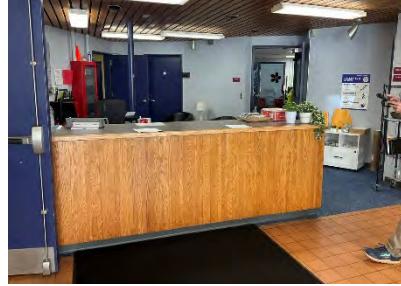
9.	Counter at Main Office and Learning Commons The service counter is >36" AFF, @ 40 1/4".	2010 ADAS 904.1

Lower a 36" wide portion of the counter to 36" max. AFF. Unit Cost: \$3,000 ea. Quantity: 1	\$3,000

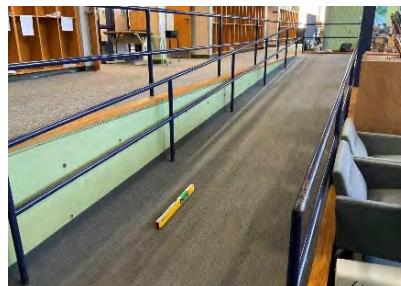
10.	Ramp Inside Library The running slope of the ramp is >8.3%, @ 9.7%.	2010 ADAS 405.2

Rebuild the ramp. Unit Cost: \$15,000 ea. Quantity: 1	\$15,000

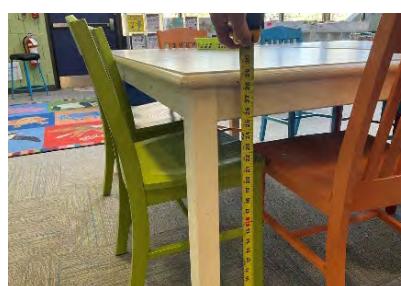
11.	Table Inside Library The table lacks the required 27" AFF min. knee clearance, @ 25 1/4".	2010 ADAS 902.2

Provide at least one table, and no less than 5% of the total number of tables and desks, that provides compliant knee and toe clearance. Unit Cost: \$250 ea. Quantity: 1	\$250

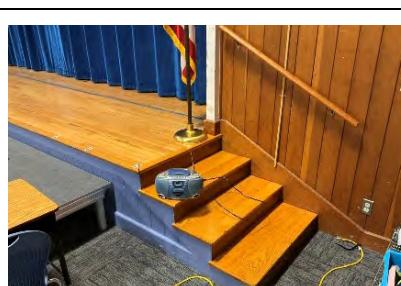
12.	Stairs to Stage inside Auditorium The stairs do not have handrails on both sides. The stairs lack the required handrail extensions at the top and bottom of the stair flight.	2010 ADAS 505.2 2010 ADAS 505.10.2

Install compliant handrails on both sides of the stairs. Unit cost: \$50/LF Est. Quantity: 18 LF	\$900

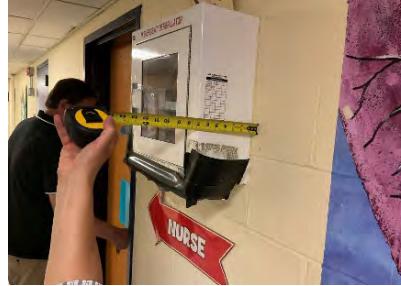
13.	<p>AED Cabinets</p> <p>The AED cabinet protrudes >4" into the circulation space, @ 7".</p> <p><i>Observed outside the nurse's office and outside the gymnasium.</i></p>	2010 ADAS 307.2

<p>Relocate the AED cabinet.</p> <p>Unit Cost: \$50 ea.</p> <p>Quantity: 2</p>	\$100
14.	<p>Sinks Inside Cafeteria and Classrooms (C Wing)</p> <p>The sink lacks the required knee/toe clearance for a forward approach.</p> <p>The sink and counters are >34" AFF, @ 34 1/2".</p> <p><i>Observed in Room 21 C only.</i></p>	<p>2010 ADAS 606.2</p> <p>2010 ADAS 606.3</p>

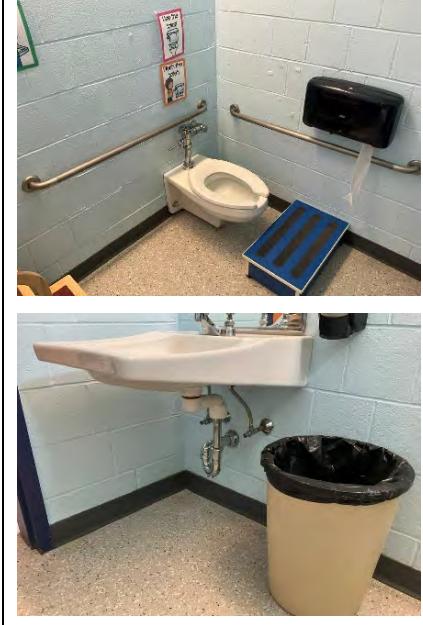
20.	<p>Kindergarten/Pre-K Single-user Children's Toilet Rooms (K Wing)</p> <p>The pipes underneath the lavatory are not insulated.</p> <p>The paper towel dispenser protrudes >4", @ 8".</p> <p>The grab bars do not provide the required clearances, @ 4", due to the toilet paper dispenser.</p>	<p>2010 ADAS 606.5 2010 ADAS 307.2 2010 ADAS 609.3</p>

<p>Install insulation around the sink pipes. Unit Cost: \$100 ea. Quantity: 4</p> <p>Relocate the paper towel dispenser. Unit Cost: \$50 ea. Quantity: 4</p> <p>Relocate the toilet paper dispenser. Unit Cost: \$50 ea. Quantity: 4</p>	\$800

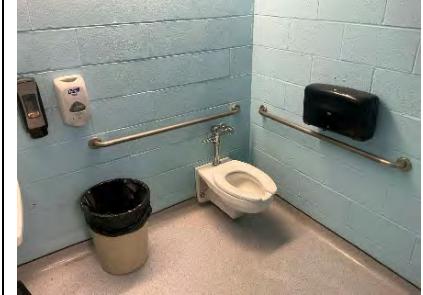
21.	<p>Single-user Toilet Room in Nurse's Office</p> <p>The grab bars are not mounted 18"-27" AFF, measured to the top of the gripping surface, @ 30 1/2".</p> <p>The grab bars do not provide the required clearances, @ 4 1/2", due to the toilet paper dispenser.</p> <p>The paper towel dispenser and shelving protrude >4", @ up to 6 1/2".</p>	<p>2010 ADAS 609.4 2010 ADAS 609.3 2010 ADAS 307.2</p>

<p>Reposition the grab bars. Unit Cost: \$50 ea. Quantity: 4</p> <p>Relocate the toilet paper dispenser. Unit Cost: \$50 ea. Quantity: 2</p> <p>Relocate the paper towel dispenser. Unit Cost: \$50 ea. Quantity: 1</p> <p>Relocate the shelving. Unit Cost: \$50 ea. Quantity: 1</p>	\$400

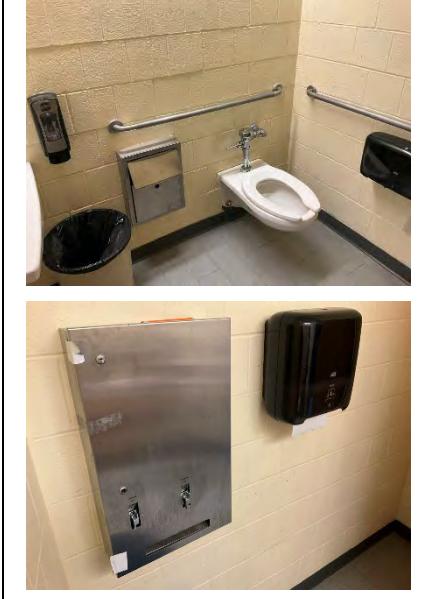
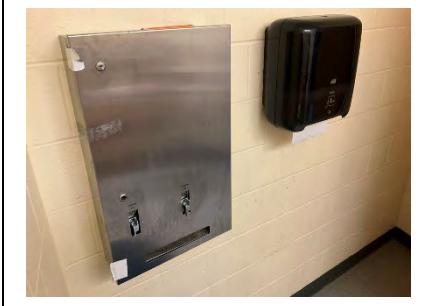
22.	<p>Gender-neutral Toilet Room near Gymnasium</p> <p>The grab bar is not mounted 33"-36" AFF, measured to the top of the gripping surface, @ 36 1/2".</p> <p>The feminine hygiene dispenser protrudes >4" into the toilet maneuvering clearance, @ 5".</p> <p>The paper towel dispenser protrudes >4" into the circulation space, @ 8".</p>	<p>2010 ADAS 309.4 2010 ADAS 307.2</p>

<p>Reposition the grab bars. Unit Cost: \$50 ea. Quantity: 2</p> <p>Relocate the feminine hygiene dispenser. Unit Cost: \$50 ea. Quantity: 1</p> <p>Relocate the paper towel dispenser. Unit Cost: \$50 ea. Quantity: 1</p>	\$200
TOTAL FOR PINE HILL SCHOOL:					\$122,100

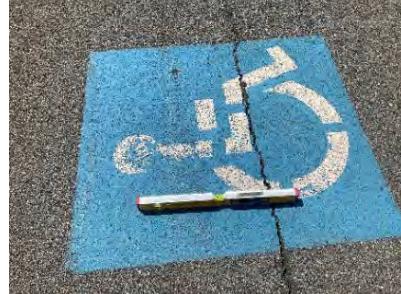
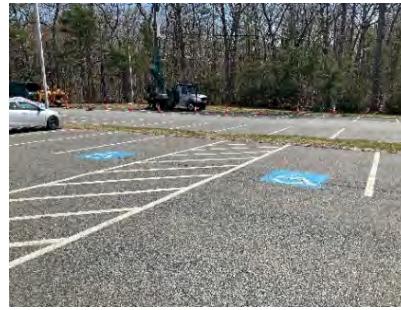
#	Barrier Statement	Code References	Photo	Proposed Mitigation	Cost
1.	<p>Parking</p> <p>The accessible parking spaces lack signs indicating they are accessible.</p> <p>The designated accessible parking spaces and their associated access aisles have slopes >2%, @ 3.5%.</p>	<p>2010 ADAS 502.6</p> <p>2010 ADAS 502.4</p>

<p>Install signs at 60" min. AFF, measured to the bottom of the sign.</p> <p>Unit Cost: \$100 ea.</p> <p>Quantity: 2</p> <p>Regrade and restripe the existing designated parking spaces and their associated access aisles.</p> <p>Unit Cost: \$1,500 ea.</p> <p>Quantity: 1 (1 space)</p>	\$1,700

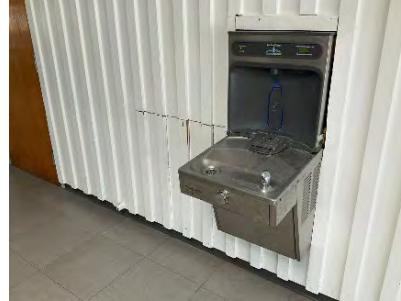
2.	<p>Drinking Fountain</p> <p>A drinking fountain for standing persons is not provided in the building.</p> <p>The drinking fountain protrudes into circulation space.</p>	<p>2010 ADAS 211.2</p> <p>2010 ADAS 307.2</p>

<p>Add a drinking fountain for standing persons.</p> <p>Unit Cost: \$1,500 ea.</p> <p>Quantity: 1</p> <p>Install partition walls on both sides of the drinking fountains.</p> <p>Unit Cost: \$250 ea.</p> <p>Quantity: 1</p>	\$1,750

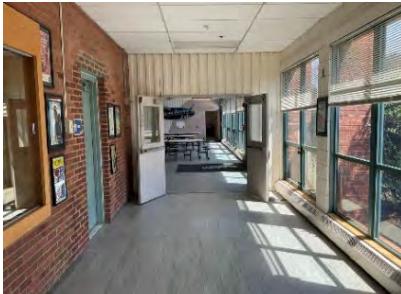
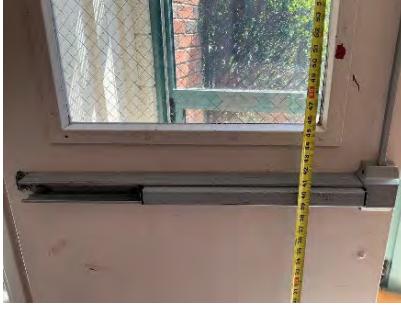
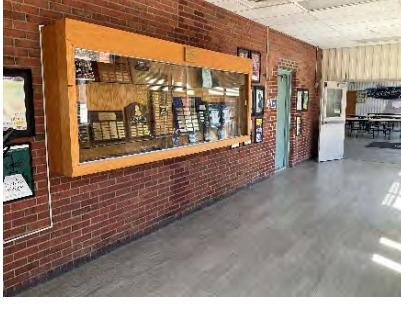
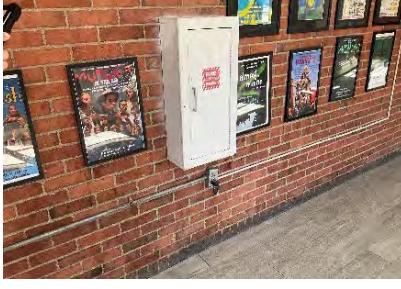
3.	<p>Corridor</p> <p>Door vision light >43" AFF, @ 46".</p> <p>The display case and the fire extinguisher cabinet protrude >4" into the circulation space, @ up to 6 ½".</p>	<p>2010 ADAS 404.2.11</p> <p>2010 ADAS 307.2</p>

<p>Replace the door. Unit Cost: \$1,000 ea. Est. Quantity: 2</p> <p>Install a cane detectable object below the display. Unit Cost: \$250 ea. Quantity: 1</p> <p>Relocate the fire extinguisher cabinet. Unit Cost: \$50 ea. Quantity: 1</p>	\$2,300
----	---	--	--	---	---------

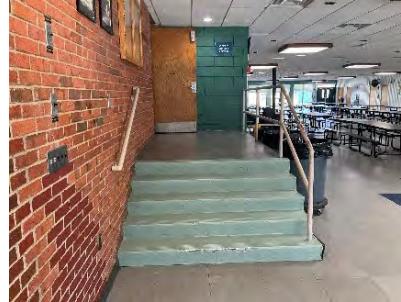
4.	<p>Stairs to Auditorium</p> <p>The stair lacks the required handrail extensions at the top and bottom of the stair flight.</p>	2010 ADAS 505.10.3

<p>Install compliant handrail extensions. Unit Cost: \$50/LF Est. Quantity: 5 LF</p>	\$250
5.	<p>Ramps to Auditorium</p> <p>The running slope of the ramp is >8.3%, @ up to 9.4%.</p> <p>The edge protection curb or barrier does not prevent the passage of a 4" min. sphere.</p>	2010 ADAS 405.2 2010 ADAS 405.9.2

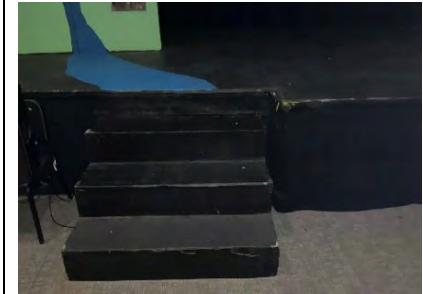
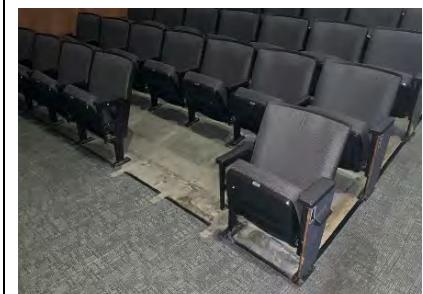
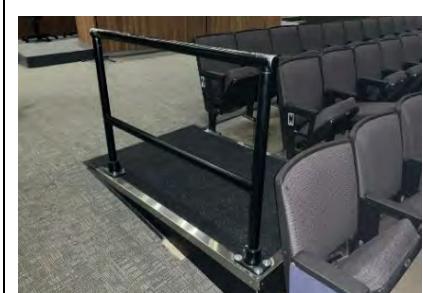
8.	<p>Auditorium</p> <p>The lift door lacks power-operated gates on both levels.</p> <p>The stairs the stage do not have handrails on both sides.</p> <p>The required number of wheelchair spaces is not provided: 6 required, only 1 provided.</p> <p>Wheelchair spaces are not dispersed horizontally (side-to-side) and vertically (front-to-back) at varying distances from the stage for an assembly area with more than 300 seats.</p> <p>The wheelchair space provided along the mid-section obstructs the aisle accessway between the row of seats.</p> <p>The number of aisle seats (with no armrests or removable/folding armrests on the aisle side) is <5% of the total number of seats in the auditorium: 4 required, 2 provided.</p>	<p>2010 ADAS 410.6</p> <p>2010 ADAS 505.2</p> <p>2010 ADAS 221.2.1.1</p> <p>2010 ADAS 221.2.3.1 & 221.2.3.2</p> <p>2010 ADAS 221.4</p>

<p>Replace the lift door/gate.</p> <p>Unit Cost: \$2,000 ea.</p> <p>Quantity: 2</p> <p>Install compliant handrails on both sides of the stairs.</p> <p>Unit Cost: \$50/LF</p> <p>Quantity: 12 LF</p> <p>Further design study is required to provide additional wheelchair and companion spaces and meet the minimum required dispersion.</p> <p>Unit Cost: \$50,000 ea.</p> <p>Quantity: 1</p> <p>Replace the armrest on the aisle seat with a folding or retractable armrest on the aisle side of the seat.</p> <p>Unit Cost: \$250 ea.</p> <p>Quantity: 2</p>	\$53,100

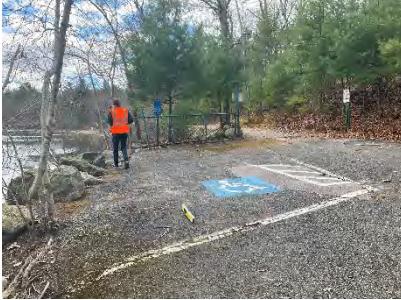
#	Barrier Statement	Code References	Photo	Proposed Mitigation	Cost
1.	<p>Parking Serving Boat Ramp/Beach</p> <p>The designated accessible parking spaces and their associated access aisles have slopes >2%, @ 4.8%.</p> <p>The designated van accessible space lacks signage indicating it is van accessible.</p>	2010 ADAS 502.4 2010 ADAS 502.6 2010 ADAS 208.2.4

Regrade and restripe the existing designated parking spaces and their associated access aisles. Unit Cost: \$1,500 ea. Quantity: 2 (1 space, 1 aisle) Install a sign at 60" min. AFF, measured to the bottom of the sign. Unit Cost: \$100 ea. Quantity: 1	\$3,100

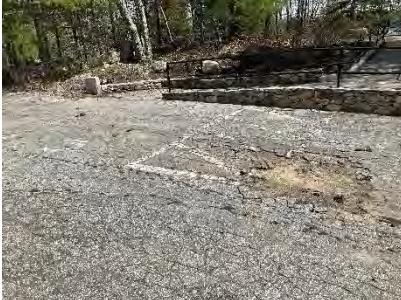
2.	<p>Parking Serving Overlook</p> <p>The designated accessible parking space and/or their associated access aisle has abrupt changes in level.</p> <p>The designated van parking space and/or its associated access aisle do not meet the minimum dimensional requirements.</p> <p>The designated van accessible space lacks signage indicating it is van accessible.</p>	2010 ADAS 502.4 2010 ADAS 502.6

Regrade and restripe the existing designated parking spaces and their associated access aisles. Unit Cost: \$1,500 ea. Quantity: 2 (1 space, 1 aisle) Install a sign at 60" min. AFF, measured to the bottom of the sign. Unit Cost: \$100 ea. Quantity: 1	\$3,100

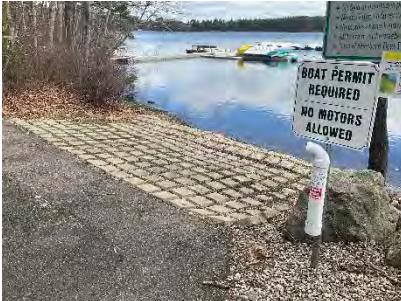
3.	<p>Boat Launch Ramp</p> <p>An accessible boat launch ramp is not provided.</p>	2010 ADAS 206.2.10

Recommendation 5C: Within the next two years, KMA recommends providing an accessible boat launch ramp for launching and retrieving trailered boats and other watercraft to and from the water.

Provide an accessible boat launch ramp. Further study required. Unit Cost: \$25/SF Est. Quantity: 1,000 SF	\$25,000

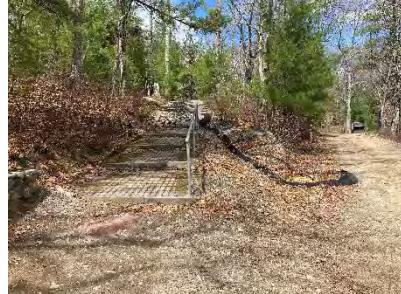
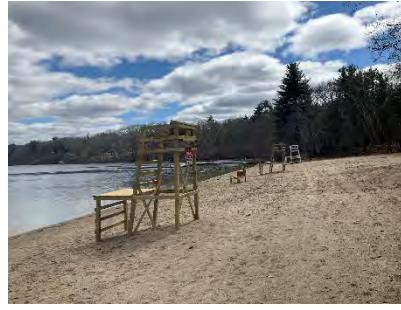
5.	Access to Water's Edge There is no accessible route to the water due to the surface condition and excessive slopes.	2010 ADAS 206.1

Provide an accessible route between the accessible parking space and the beach. Additional study required. Unit Cost: \$25/SF Est. Quantity: 1,200 SF	\$30,000
TOTAL FOR FARM POND BEACH:					\$77,200

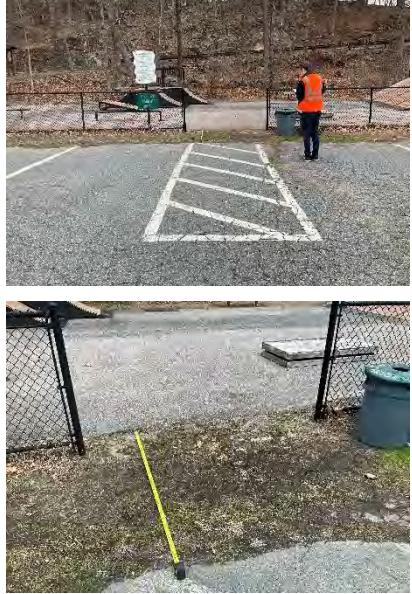
4.	<p>Skate Park</p> <p>The skate park is not along an accessible route due to the grass along the parking lot.</p>	2010 ADAS 206.1

<p>Provide an accessible route between the stripped area on the parking lot and the skate park.</p> <p>Unit Cost: \$25/SF</p> <p>Est. Quantity: 25 SF</p>	\$625
5.	<p>Basketball Courts</p> <p>The skate park is not along an accessible route due to the grass along the parking lot.</p>	2010 ADAS 206.1

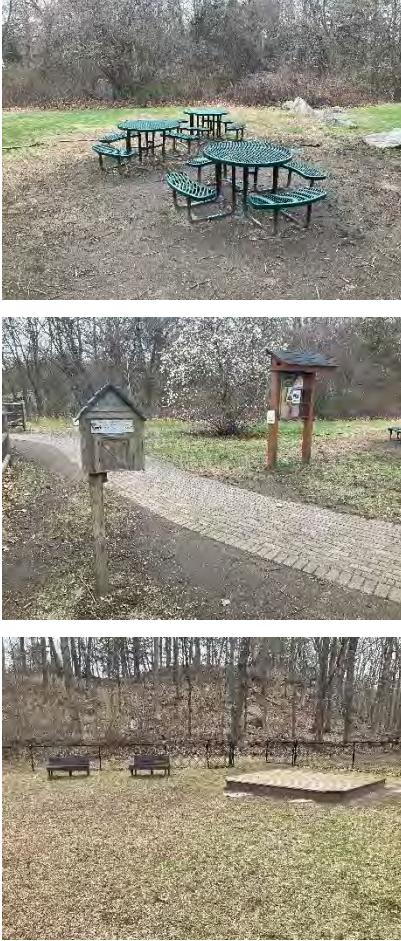
6.	<p>Site Amenities Some site amenities (i.e., picnic tables, park kiosk, little free library) are not located along an accessible route due to the grass surface.</p>	2010 ADAS 206.1

<p>Provide at least one of each type of amenity along an accessible route. Unit Cost: \$25/SF Est. Quantity: 100 SF</p>	\$2,500
TOTAL FOR WARD J. PARKS RECREATION AREA:					\$4,600

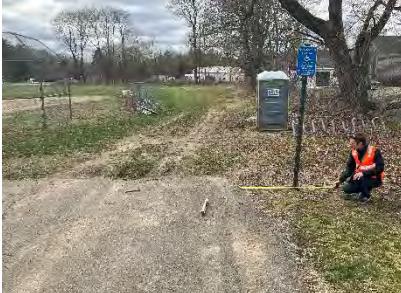
#	Barrier Statement	Code References	Photo	Proposed Mitigation	Cost
1.	<p>Parking</p> <p>The designated accessible parking spaces and their associated access aisles have slopes >2%, @ 7.6%.</p> <p>The access aisle is not striped to discourage parking.</p>	2010 ADAS 502.4 2010 ADAS 502.3.3

<p>Regrade and restripe the existing designated parking spaces and their associated access aisles.</p> <p>Unit Cost: \$1,500 ea.</p> <p>Quantity: 2 (1 space, 1 aisle)</p>	\$3,000

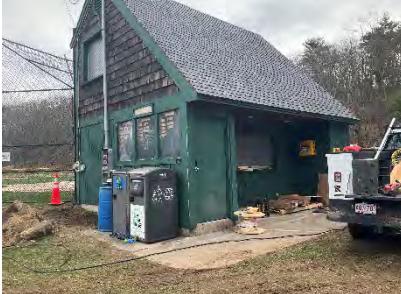
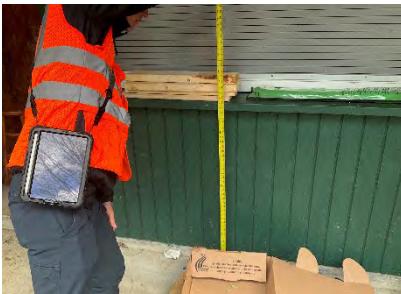
2.	<p>Concession Stand</p> <p>The concession stand is not along an accessible route due to the grass and gravel.</p> <p>The height of the counter surface measured >36", @ 42".</p>	2010 ADAS 206.1 2010 ADAS 902

<p>Provide an accessible route to the concession stand. The accessible route may be combined with the accessible route connecting the bleachers serving baseball field #1.</p> <p>Unit Cost: \$25/SF</p> <p>Est. Quantity: 150 SF</p> <p>Lower a 36" wide portion of the counter to 36" max. AFF.</p> <p>Unit Cost: \$750 ea.</p> <p>Quantity: 1</p>	\$4,500

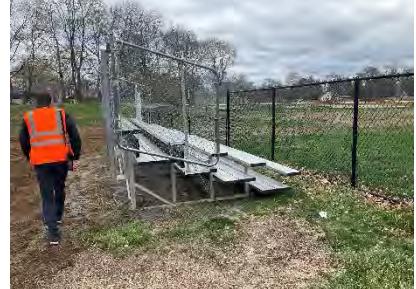
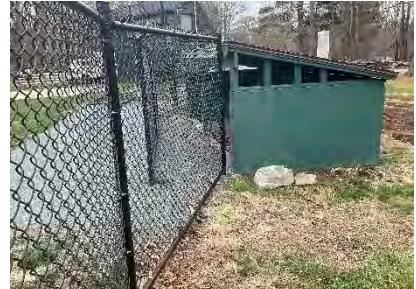
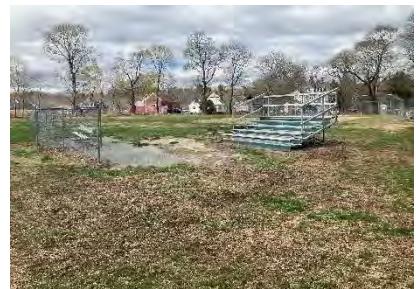
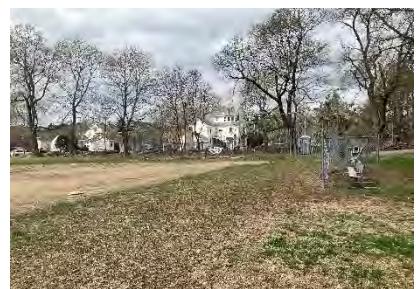
3.	<p>Baseball and Lacrosse Fields</p> <p>None of sports fields provide an accessible route connecting elements and spaces within areas of sports activities, including an:</p> <ul style="list-style-type: none"> • Accessible route from the accessible parking spaces to both types of sports fields. • Accessible route to team player seating areas (i.e., dugouts serving the baseball fields). • Accessible route to spectator seating (i.e., benches and bleachers serving the baseball fields). 	2010 ADAS 206.1

<p>Provide an accessible route between the accessible parking space and at least one of each type of sports fields. The accessible route may be shared between sports fields. Provide at least one of each type of sports fields along an accessible route, including an accessible route to all of the field's elements and spaces within areas of sports activities. For bleachers, provide the required number of wheelchair spaces and at least one companion seat per wheelchair space.</p> <p>Unit Cost: \$25/SF Est. Quantity: 4,000 SF</p>	\$100,000

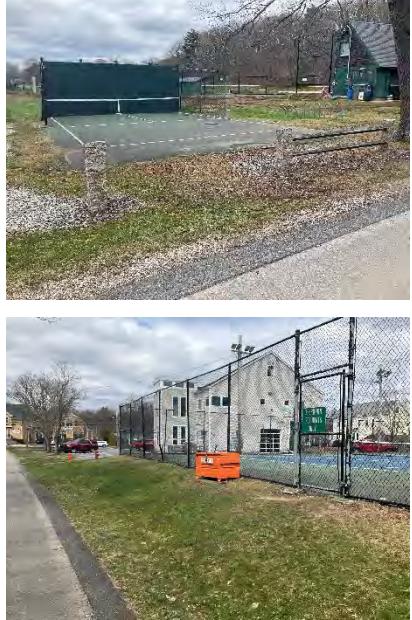
4.	<p>Tennis Courts The tennis courts are not along an accessible route due to the grass and gravel.</p>	2010 ADAS 206.1

<p>Provide an accessible route to the tennis courts between court #4 and the practice wall. Unit Cost: \$25/SF Est. Quantity: 320 SF</p>	\$8,000
5.	<p>Portable Toilet Unit The portable toilet unit is not along an accessible route due to the grass and gravel.</p>	2010 ADAS 206.1

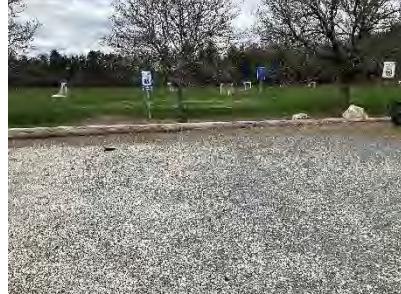
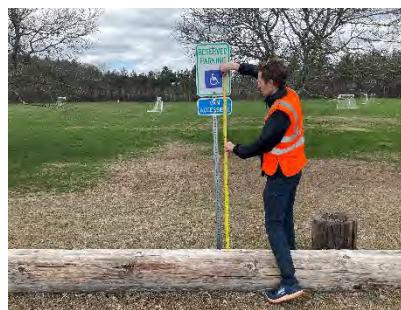
#	Barrier Statement	Code References	Photo	Proposed Mitigation	Cost
1.	Parking (Main Parking Lot) The surface of the parking lot is not stable, firm, and slip resistant due to the grass and gravel surface.	2010 ADAS 502.4

Pave and stripe a portion of the parking lot to add one van accessible parking space and one accessible parking space, including their associated access aisle. Unit Cost: \$1,500 per space or aisle Quantity: 3 (2 spaces, 1 aisle)	\$4,500
2.	Parking (Along Field #10) The surface of the parking lot is not stable, firm, and slip resistant due to the grass and gravel surface.	2010 ADAS 502.4

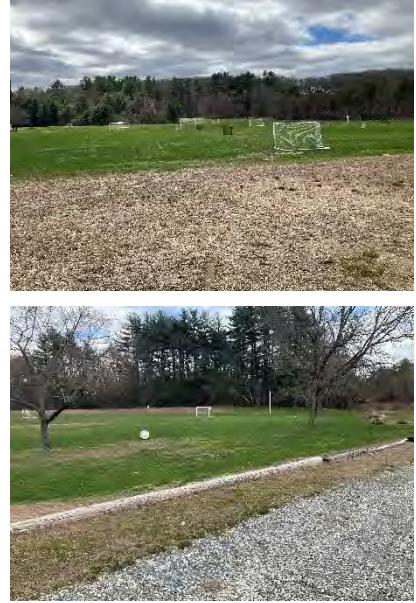
3.	<p>Soccer and Lacrosse Fields</p> <p>None of the soccer and lacrosse fields provide an accessible route connecting elements and spaces within areas of sports activities.</p>	2010 ADAS 206.1

<p>Provide an accessible route between both accessible parking spaces and one of each type of soccer and lacrosse fields they serve. If team benches are provided, the accessible route must also connect the team benches along the sidelines of the designated accessible fields.</p> <p>Unit Cost: \$25/SF Est. Quantity: 1,000 SF</p>	\$25,000
4.	<p>Tennis Practice Wall</p> <p>The tennis practice wall is not along an accessible route due to the grass and gravel.</p>	2010 ADAS 206.1

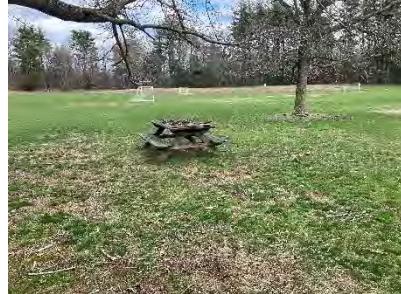
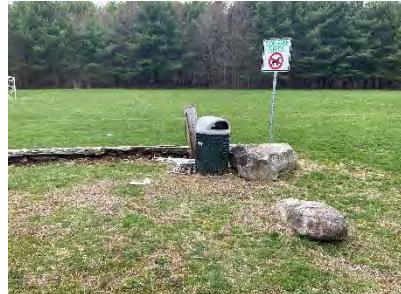
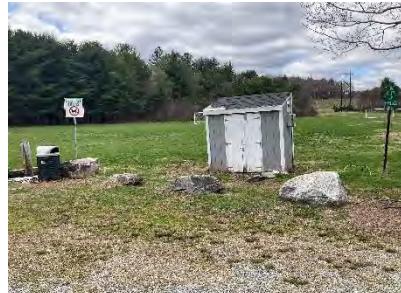
5.	<p>Site Amenities</p> <p>Some site amenities (i.e., picnic tables, trash cans, and the storage shed) are not located along an accessible route due to the grass surface.</p>	2010 ADAS 206.1

<p>Provide at least one of each type of amenity along an accessible route.</p> <p>Unit Cost: \$25/SF</p> <p>Est. Quantity: 200 SF</p>	\$5,000
----	---	-----------------	--	---	---------

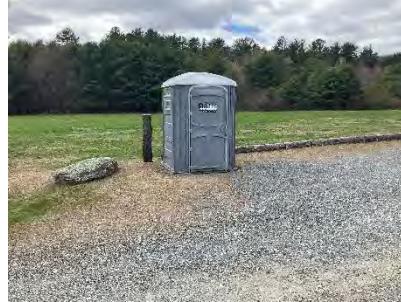
6.	Portable Toilet Unit The portable toilet unit is not along an accessible route due to the grass and gravel.	2010 ADAS 206.1

Provide an accessible route to the portable toilet unit. Unit Cost: \$25/SF Est. Quantity: 100 SF	\$2,500
TOTAL FOR LAUREL FARM FIELDS:					\$90,000

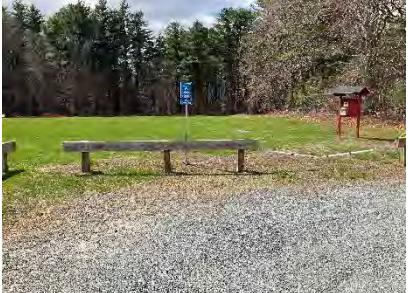
#	Barrier Statement	Code References	Photo	Proposed Mitigation	Cost
1.	<p>Parking</p> <p>The surface of the parking lot is not stable, firm, and slip resistant due to the grass and gravel surface.</p>	2010 ADAS 502.4

<p>Pave and stripe a portion of the parking lot to add one van accessible parking space, including its associated access aisle.</p> <p>Unit Cost: \$1,500 per space or aisle</p> <p>Quantity: 2 (1 space, 1 aisle)</p>	\$3,000

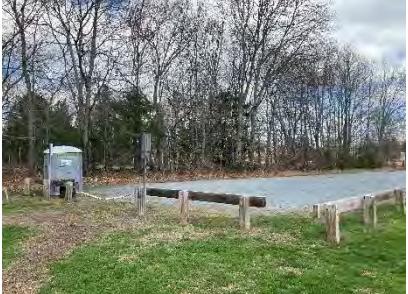
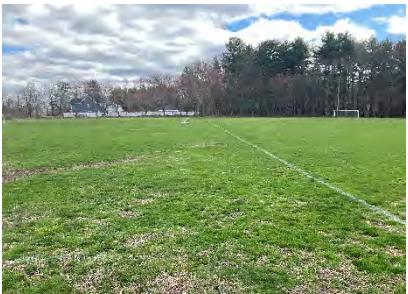
2.	<p>Soccer Fields</p> <p>None of the soccer fields provide an accessible route connecting elements and spaces within areas of sports activities, including an:</p> <ul style="list-style-type: none"> Accessible route from the accessible parking space to the fields. Accessible route to team player seating areas (team benches along the sidelines of the soccer field). 	2010 ADAS 206.1

<p>Provide an accessible route between the accessible parking space and both soccer fields. The accessible route may be shared between field #1 (11v11) and field #2 (9v9) and must connect the team benches along the sidelines of the soccer field.</p> <p>Unit Cost: \$25/SF</p> <p>Est. Quantity: 1,000 SF</p>	\$25,000
