Appendix B. Physical Environment Audit

This Appendix includes three sections from [KMA](#), the project team's physical environment experts:

TOWN HALL

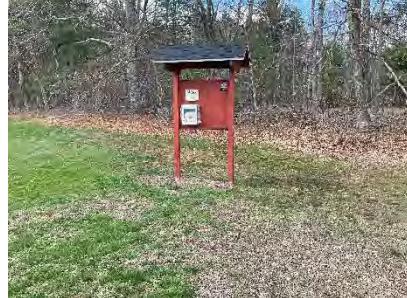
3.	First Aid Kiosk The kiosk with an automated external defibrillator is not along an accessible route due to the grass and gravel.	2010 ADAS 206.1

Provide an accessible route to the trailhead kiosk. Unit Cost: \$25/SF Est. Quantity: 100 SF	\$2,500
4.	Portable Toilet Unit The portable toilet unit is not along an accessible route due to the grass and gravel.	2010 ADAS 206.1

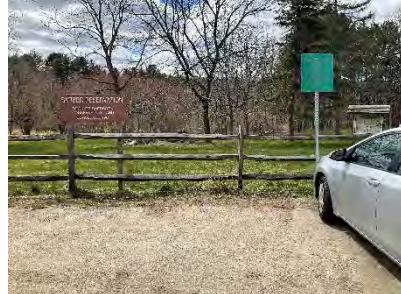
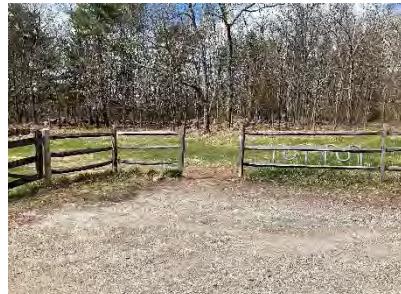
#	Barrier Statement	Code References	Photo	Proposed Mitigation	Cost
1.	<p>Parking</p> <p>There is an insufficient number of accessible parking spaces.</p> <p>There are no accessible van spaces provided, or their associated access aisles.</p> <p>The surface of the parking lot is not stable, firm, and slip resistant due to the gravel or sand surface.</p>	<p>2010 ADAS 208.2</p> <p>2010 ADAS 502.2</p> <p>2010 ADAS 502.4</p>

<p>Pave and stripe a portion of the parking lot to add one van accessible parking space, including its associated sign (containing the designation “van accessible”) and access aisle.</p> <p>Unit Cost: \$1,500 per space or aisle</p> <p>Quantity: 2 (1 space, 1 aisle)</p>	\$3,000

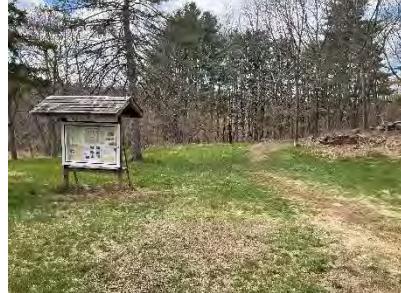
2.	<p>Trailhead Kiosk</p> <p>The kiosk with information about the property, including maps, is not along an accessible route due to the grass, gravel, or mulch.</p>	2010 ADAS 206.1

<p>Provide an accessible route to the trailhead kiosk.</p> <p>Unit Cost: \$25/SF</p> <p>Est. Quantity: 450 SF</p>	\$11,250

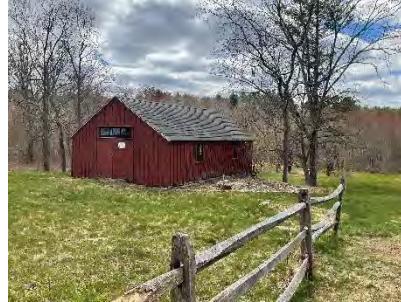
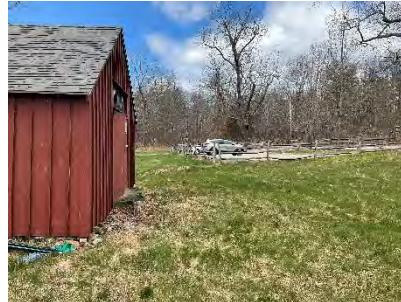
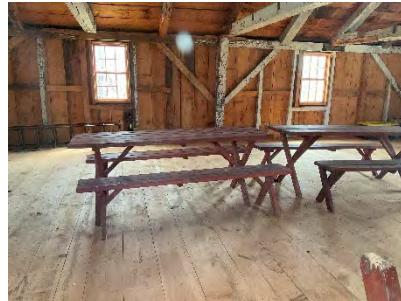
3.	Access to Barn The barn is not located along an accessible route due to the grass surface.	2010 ADAS 206.1

Provide an accessible route to the entrance of the barn. Unit Cost: \$25/SF Est. Quantity: 200 SF	\$5,000
TOTAL FOR BARBER RESERVATION:					\$19,250

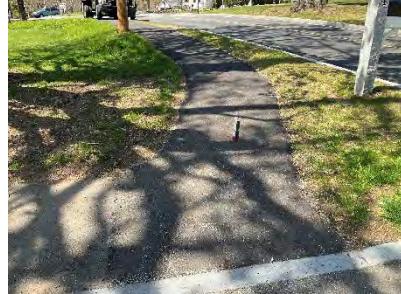
#	Barrier Statement	Code References	Photo	Proposed Mitigation	Cost
1.	Sidewalk Along Sanger Street (North of Parking at Library) The walkway has running slopes >5%, up to 8.2%.	2010 ADAS 403.3

Regrade the walkway. Unit Cost: \$25/SF Est. Quantity: 150 SF	\$3,750
2.	Intersection of Main Street and Washington Street The crosswalk does not join an accessible route.	2010 ADAS 206.2.1

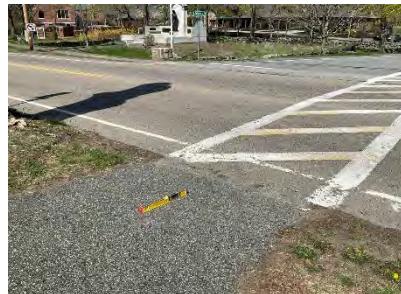
Install a curb ramp at the crosswalk. Unit Cost: \$2,500 ea. Quantity: 2	\$5,000
3.	Intersection of South Main Street and Village Way The crosswalk does not join an accessible route.	2010 ADAS 206.2.1

Install a curb ramp at the crosswalk. Unit Cost: \$2,500 ea. Quantity: 2	\$5,000

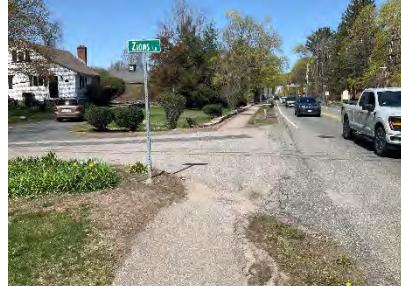
4.	Intersection of North Main Street and Zion's Lane The crosswalk does not join an accessible route.	2010 ADAS 206.2.1

Install a curb ramp at the crosswalk. Unit Cost: \$2,500 ea. Quantity: 2	\$5,000
5.	Pedestrian Signal (In Front of C&L Plaza) The pedestrian signal lacks the required clear floor space adjacent to it.	2010 ADAS 206.2.1

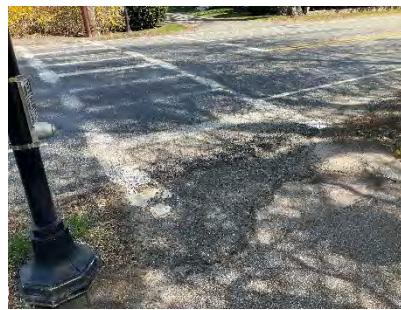
Regrade the walkway. Unit Cost: \$25/SF Est. Quantity: 20 SF	\$500
6.	Intersection of North Main Street and Elliot Street The crosswalk does not join an accessible route.	2010 ADAS 206.2.1

Install a curb ramp at the crosswalk. Unit Cost: \$2,500 ea. Quantity: 2	\$5,000

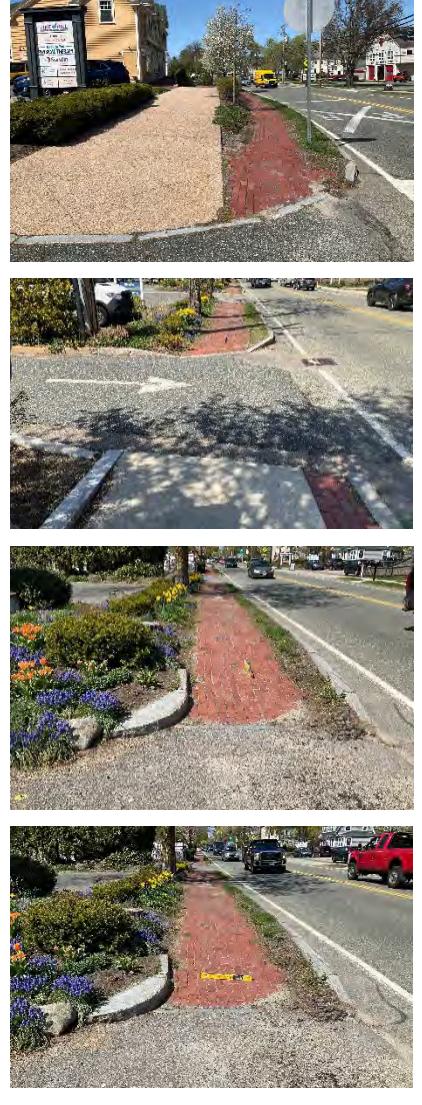
7.	<p>Sidewalk Along North Main Street, North of Railroad</p> <p>The sidewalk along the western side of North Main Street (with mostly brick surface, except for sections in concrete connecting recently altered crosswalks):</p> <ul style="list-style-type: none"> • Lacks curb ramps at multiple driveways serving businesses, north of the railroad. • Have running slopes >5%, @ up to 10.6%. 	<p>2010 ADAS 206.2.1 2010 ADAS 403.3</p>

<p>Install a curb ramp at the driveway. Further study required to prioritize alterations.</p> <p>Unit Cost: \$2,500 ea. Quantity: 10</p> <p>Regrade the walkway.</p> <p>Unit Cost: \$25/SF Est. Quantity: 200 SF</p>	\$30,000
TOTAL FOR REPRESENTATIVE SIDEWALKS:		\$54,250
